UNDERGROUND SANITARY CAMERA  
INVESTIGATION  
Bordeaux Club

Bordeaux Club  
2900 Gulf Shore Blvd N.  
Naples, FL 34103

Prepared By: Brandon Clark &  
Larry Prater  
Date: 04/20/2024

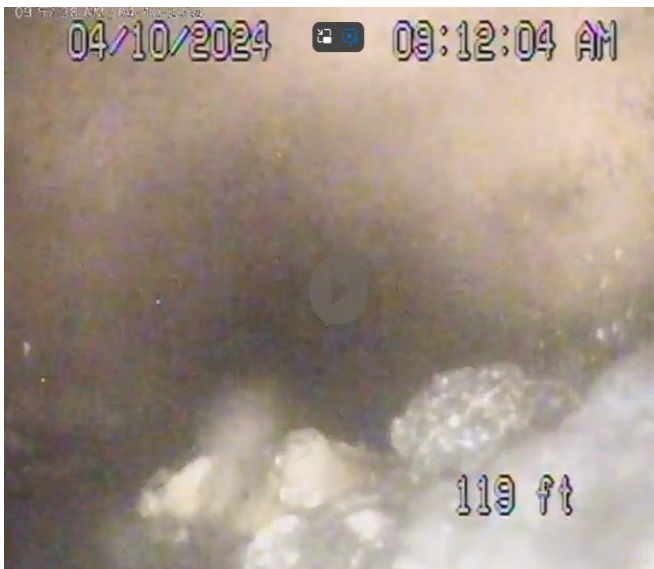
Main Line with sand and major build up

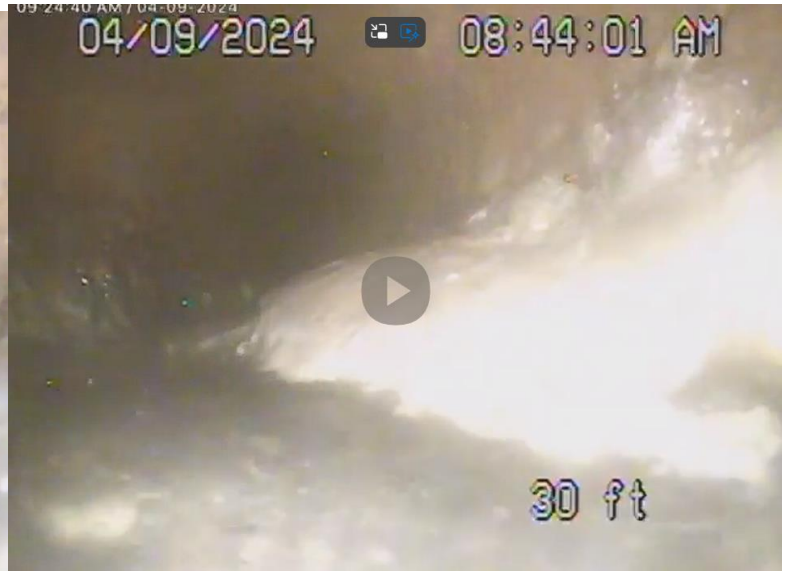
Unit 101 with major ledging and build up

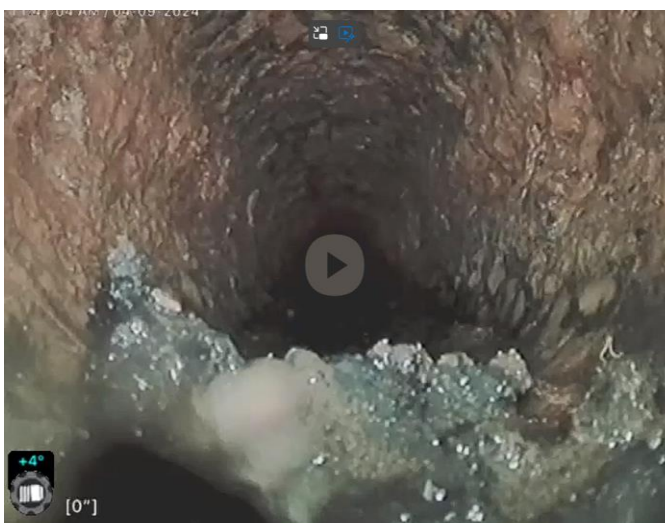
From unit 107 to unit108 major build up

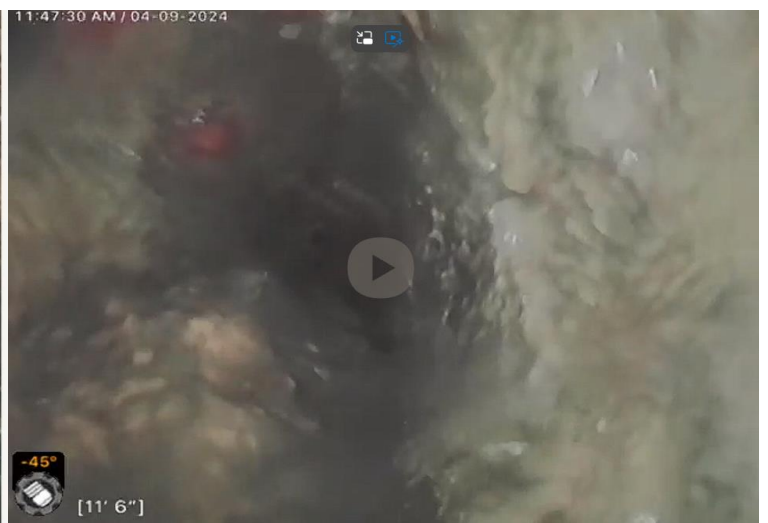
From unit 107 to unit 108 major ledging and build up

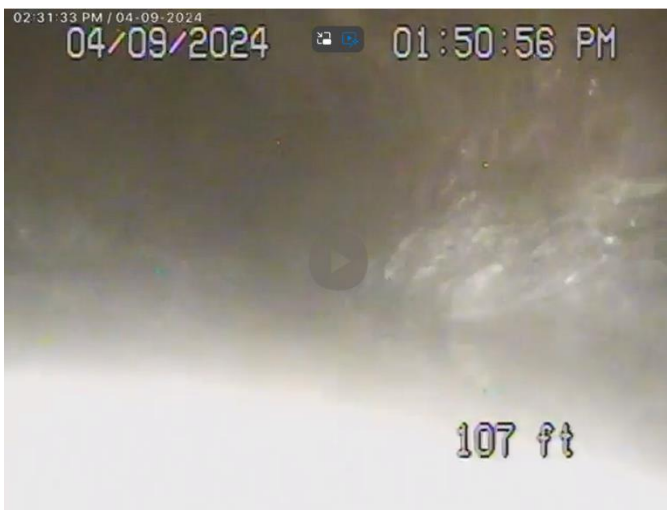
**Unit 110 major build up and ledging**

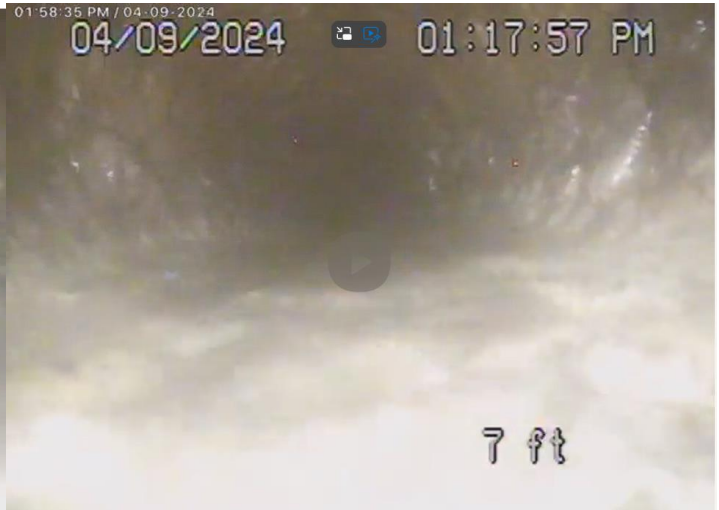
**Unit 114 major build up and ledging**

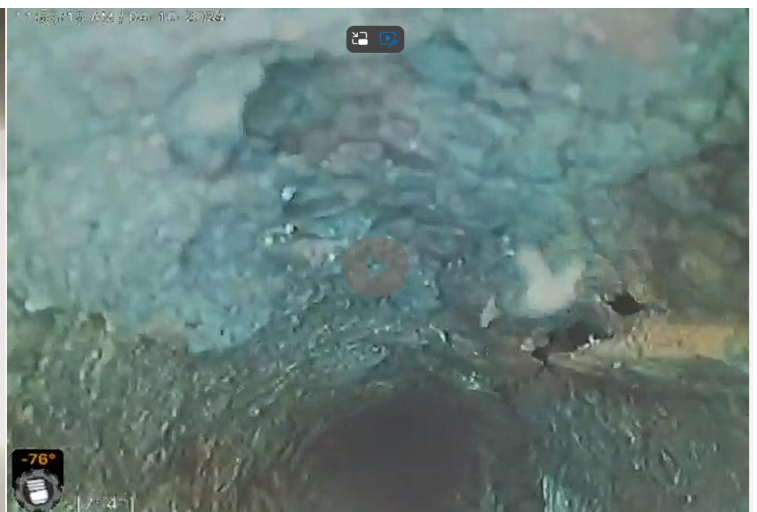
**Unit 112 Blockage and major build up and ledging Tiki pipe cracked and needs replaced**
