RESERVE STUDY REPORT

The Bordeaux Club
2900 Gulf Shore Boulevard North
Naples, Collier County, Florida
Velocity Project Number: 17-256

Date: October 10, 2018

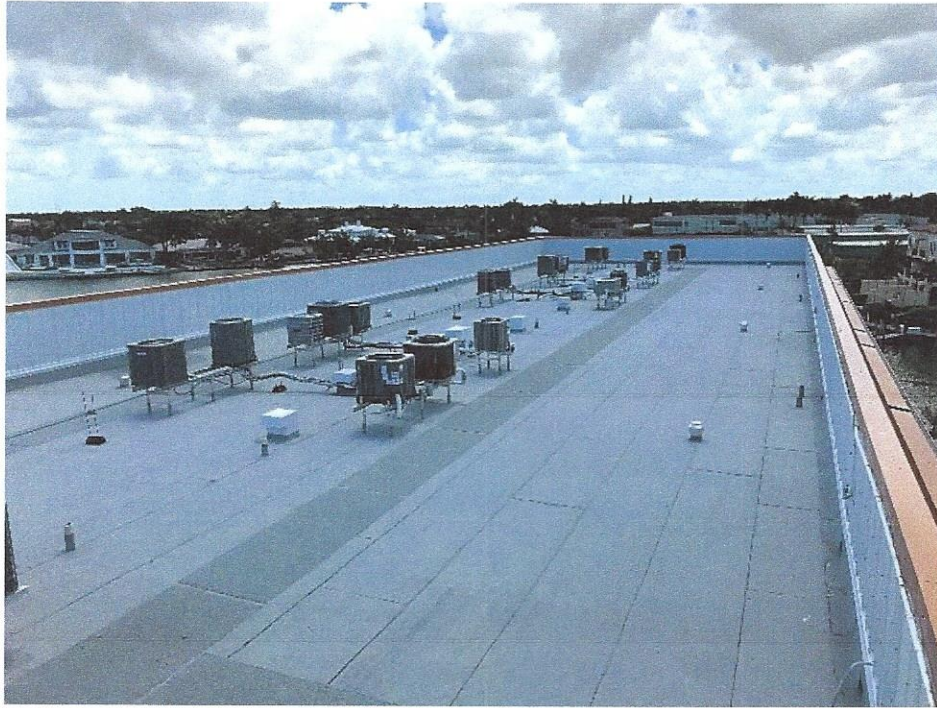
Photograph 1: North Building Roof

The north building roof reserve component consists of the cost to replace the flat roof at the north building. The Property Manager informed Velocity that the roof was last replaced in 2018. The flat roof measures approximately 7,500 sq. ft. for a total of approximately 75 squares of roof. With the exception of two localized areas of standing water near scuppers, the roof appeared to be in excellent condition at the time of Velocity's site visit. The two localized areas of standing water should be corrected to prevent premature deterioration of the roofing system.

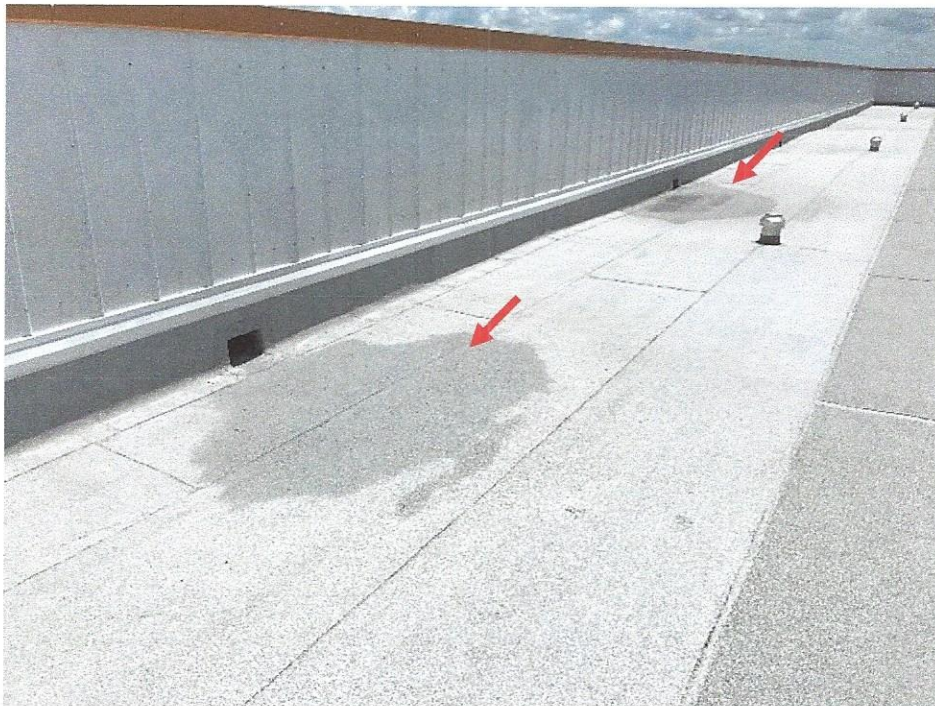
Photograph 2: Standing water near scuppers on the north side of the North Building Roof

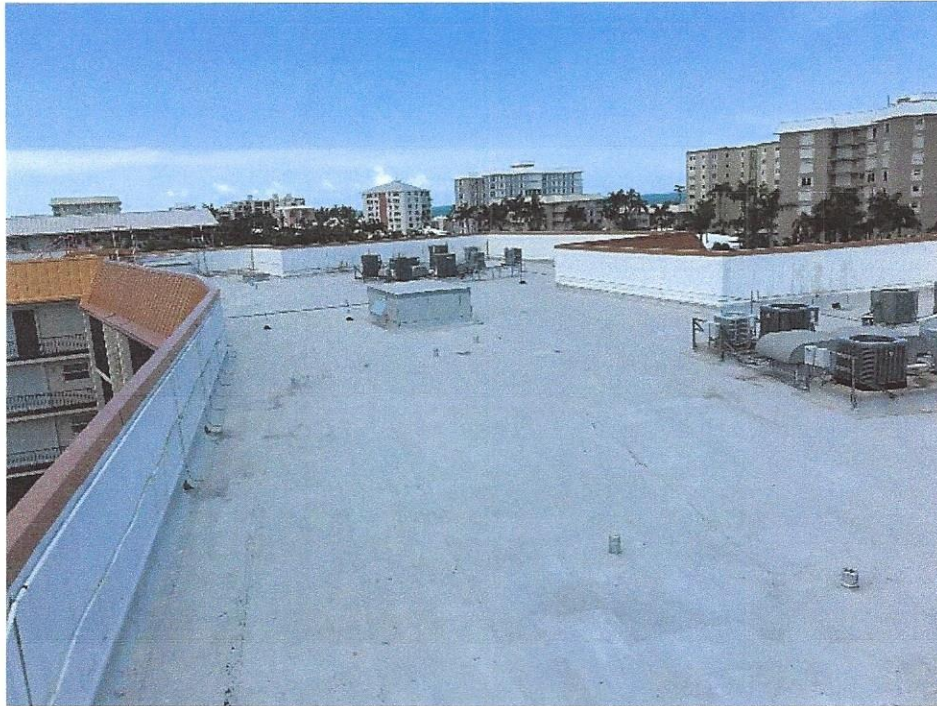
Photograph 3: West Building Roof

It should be noted that a liquid applied membrane was observed throughout the west roof. The purpose of installing a liquid applied membrane is to extend the useful life of the roof. The date of application of the liquid membrane is unknown.

The roof appeared to be in poor to fair overall condition at the time of Velocity's site visit. Severe cracking was observed in the membrane, throughout the cap sheet, and in the roof cement at nearly all cap sheet end laps. Furthermore, Velocity observed localized areas of standing water and severely rusted fasteners throughout the parapet walls.

The Property Manager informed Velocity that West Coast estimated a remaining useful life of 6 years for the west building roof. However, based on Velocity's observations, it is estimated that the remaining useful life of the west building roof is approximately 2 to 3 years. For the purposes of this reserve study, Velocity has assumed that the roof will be replaced in 2021 and every 20 years thereafter.

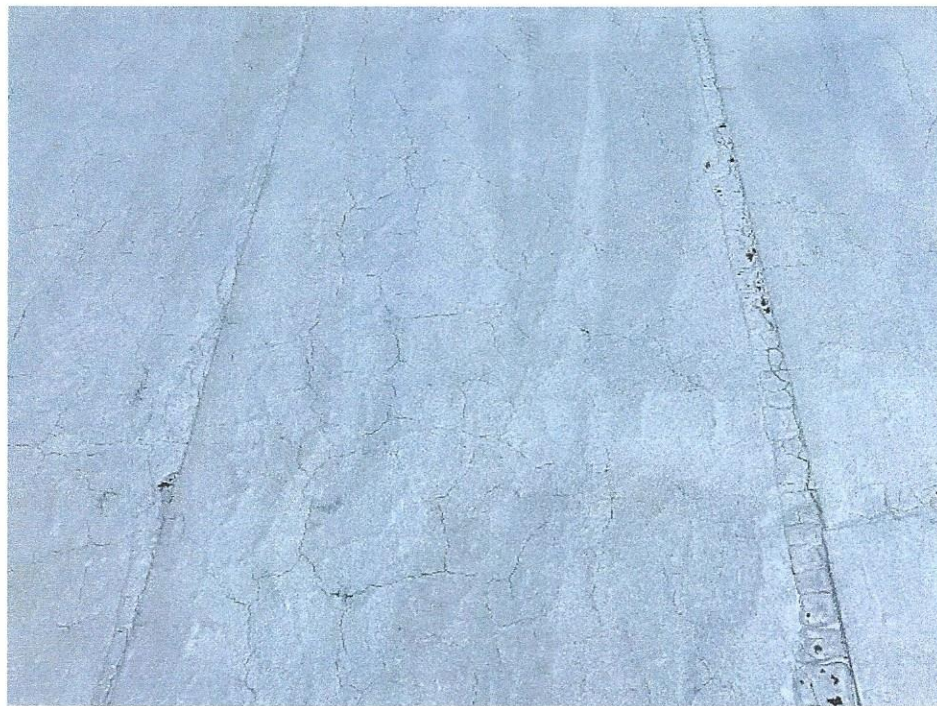
Photograph 4: Cracking throughout the liquid membrane and cap sheet on the West Building Roof

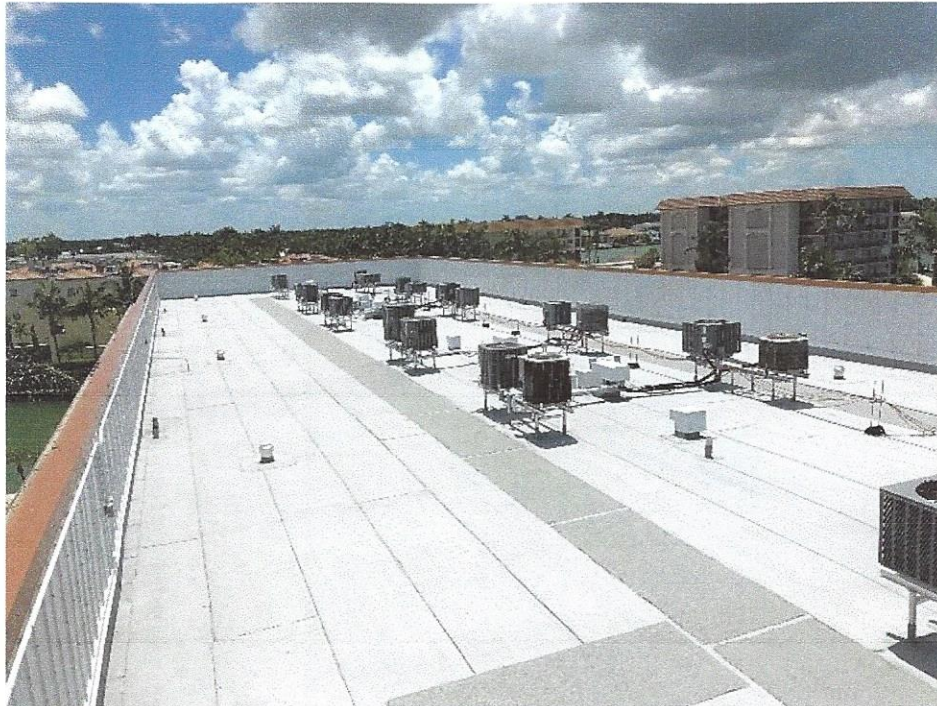
Photograph 5: South Building Roof

The south building roof reserve component consists of the cost to replace the flat roof at the south building. The Property Manager informed Velocity that the roof was last replaced in 2018. The roof measures approximately 7,500 sq. ft. for a total of approximately 75 squares of roof. The roof appeared to be in excellent overall condition at the time of Velocity's site visit.

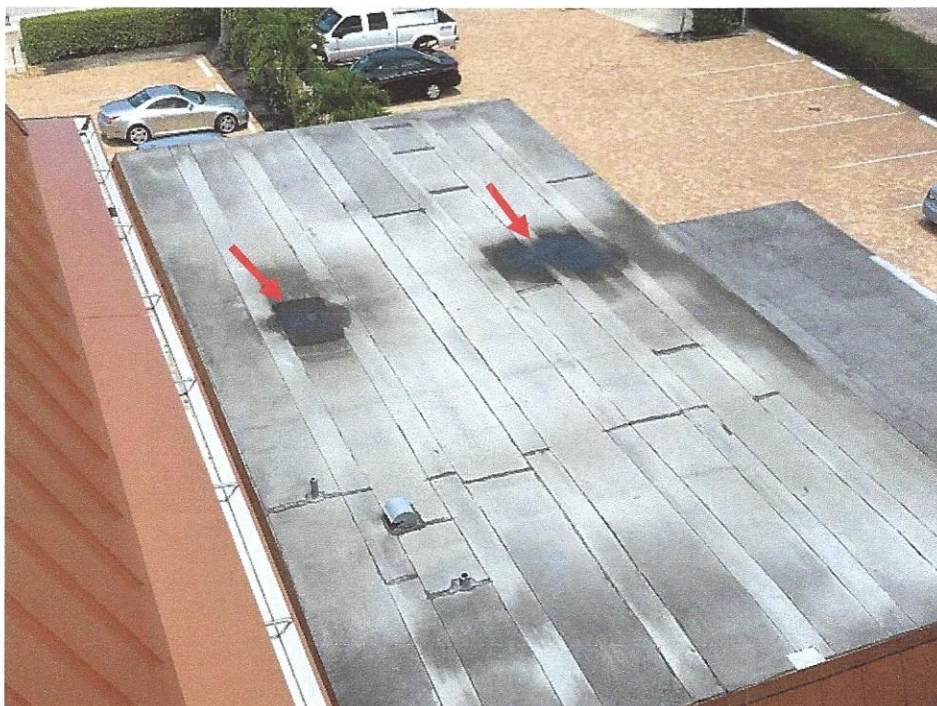
The office building roof reserve component consists of the cost to replace the flat roof at the office building. The Property Manager informed Velocity that the roof was last replaced in 2005. The roof measures approximately 1,100 sq. ft. for a total of 11 squares of roof. With the exception of localized areas of standing water, the roof appeared to be in good overall condition at the time of Velocity's site visit. The localized areas of standing water should be corrected to prevent premature deterioration of the roofing system.

Photograph 6: Office Building Roof and areas of standing water

Velocity has estimated the cost to replace the office building roof based upon the numbers provided for the north and south buildings. Due to the observed condition of the roof, Velocity anticipates that the office building roof will be replaced coincidingly with the maintenance building roof in 2027, and every 20 years thereafter.

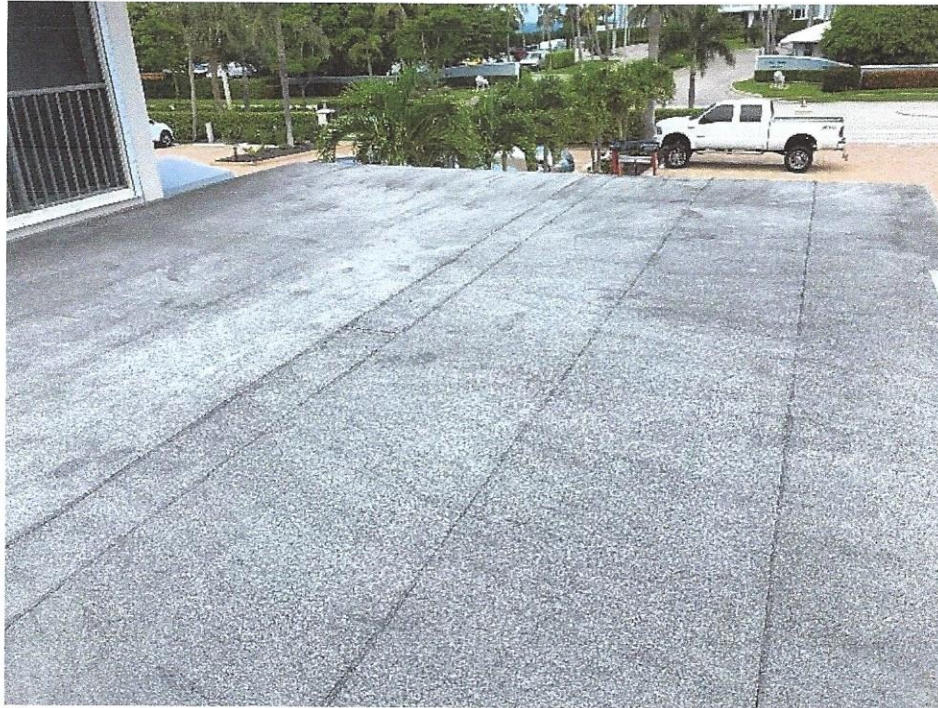
Photograph 7: Maintenance Building Roof

The roof appeared to be in fair to good overall condition at the time of Velocity's site visit. Minor cracking was observed in the cap sheet and in the roof cement at the cap sheet end laps. Additionally, granule loss in the cap sheet was observed in some areas.

Based on Velocity's site visit, it is estimated that the remaining useful life of the maintenance building roof is approximately 7 to 9 years. Velocity has estimated the cost to replace the maintenance building roof based upon the numbers provided for the north and south buildings. Due to the observed condition of the roof, Velocity anticipates that the maintenance building roof will be replaced coincidingly with the office building roof in 2027, and every 20 years thereafter.

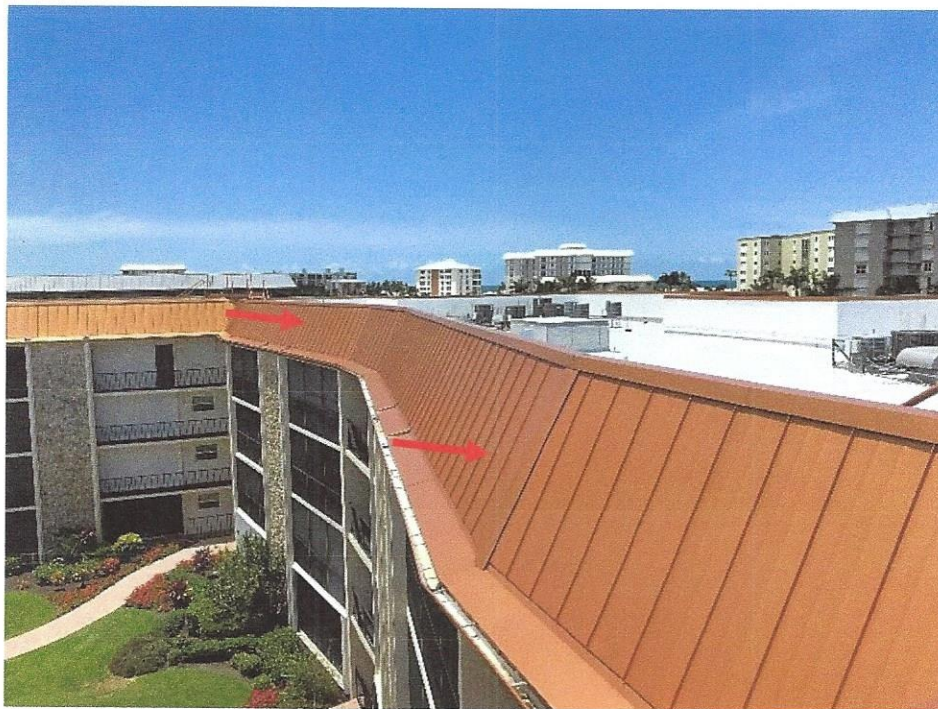
The mansard roofs reserve component consists of the cost to replace the standing seam metal mansard roofs throughout the community. The Property Manager informed Velocity that all mansard roofs were replaced in 2005. The mansard roofs appeared to be in good overall condition at the time of Velocity's site visit.

Photograph 8: Typical Standing Seam Metal Mansard Roofs

It is anticipated that the mansard roofs will be replaced in 2035 and every 30 years thereafter.

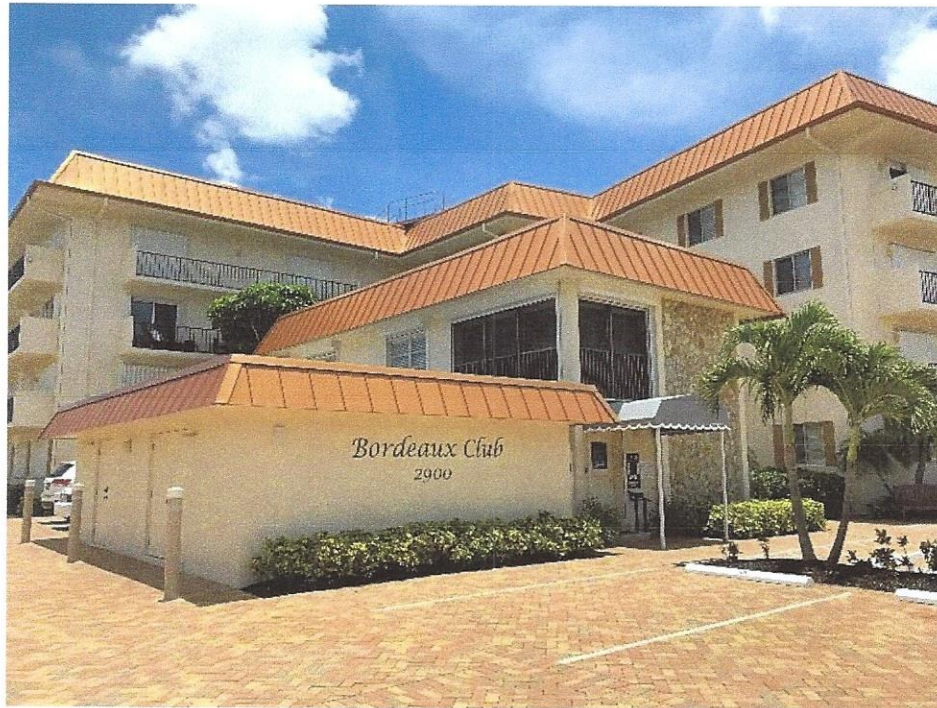
The painting reserve component consists of the cost to repaint the exterior of the condominium buildings, the maintenance building, the office building, and the chickee hut. It is understood that the condominium buildings, the maintenance building, the office building, and the chickee hut were last repainted in 2013. With the exception of small areas of peeling paint and minor stucco cracks, the paint on the buildings and the chickee hut was in good overall condition at the time of Velocity's site visit. Stucco cracks should be patched the next time the buildings are repainted.

Photograph 9: Maintenance Building, Office Building, and Typical Condominium Building

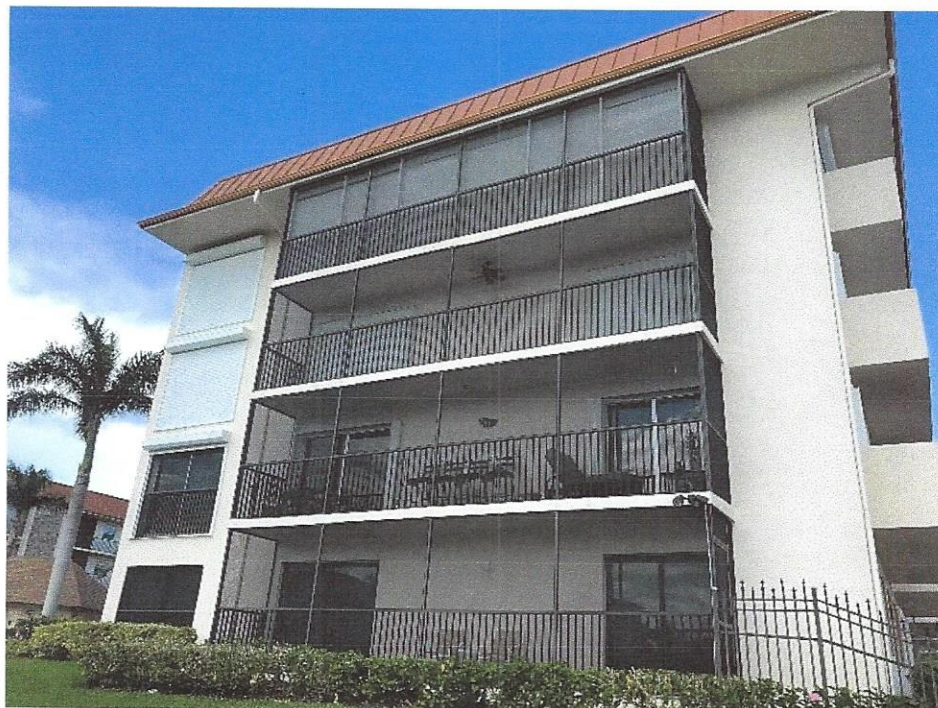
The screens reserve component consists of the cost to replace all of the mesh screens every 10 years and the aluminum screen enclosures every 20 years. The screens appeared to be in good overall condition at the time of Velocity's site visit. However, caulk was not observed on the exterior of the aluminum screen enclosures located along the walkways of the north and south building. The aluminum screen enclosures should be properly caulked to prevent water intrusion and deterioration of the enclosure fasteners.

Photograph 10: East Facing Screens on North Building

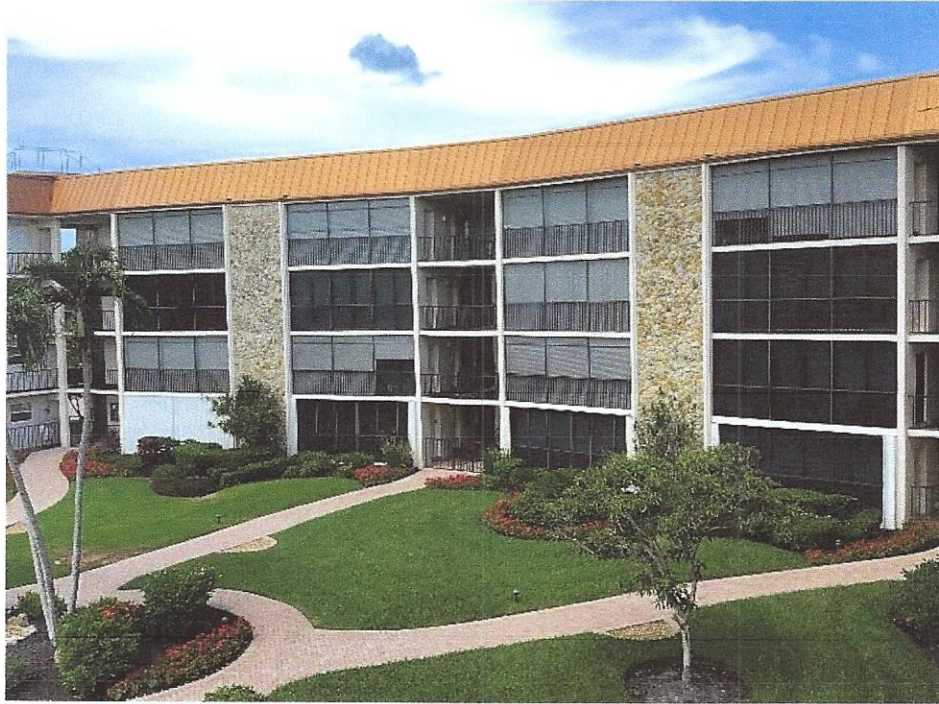
Photograph 11: East Facing Screens on West Building

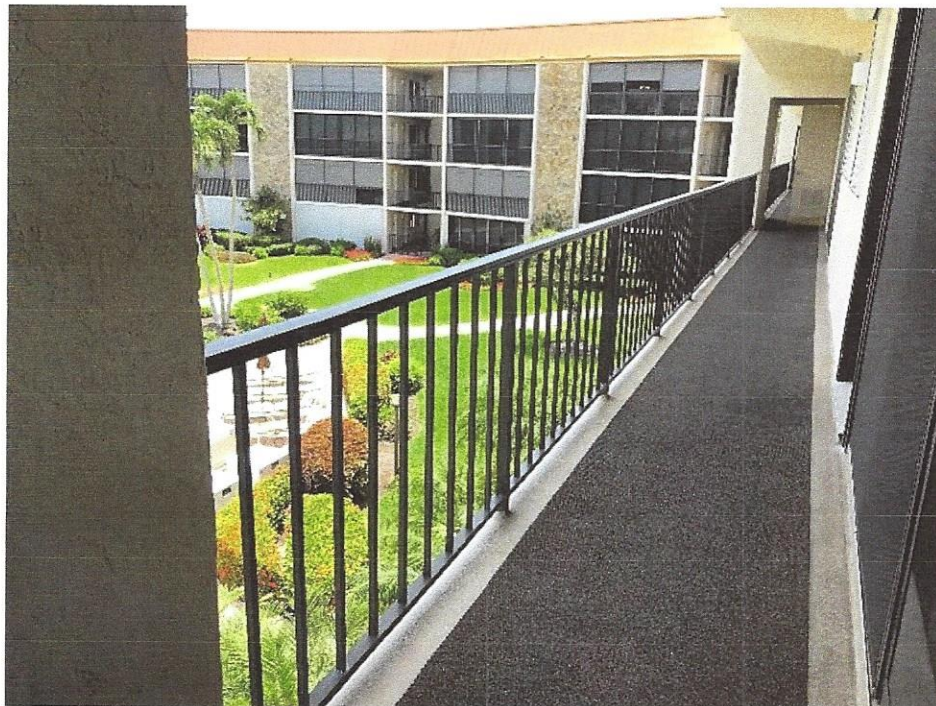
The Association indicated that the condition of the walkway railings is a concern to the residents. Based upon the 2018 Adopted Reserve Funding spreadsheet provided to Velocity, it is assumed that the walkway railings were last replaced in approximately 2000. It should be noted that the railings were cleaned and coated in 2016 by Service Contracting Solutions (previously known as Service Painting of Florida). Velocity observed the walkway railings during our site visits and, with the exception of some rusting hardware and gaps in the handrails, the walkway railings appeared to be in good overall condition. Minor repairs should be performed on an as needed basis.

The Association has also indicated that they are aware that the railings do not comply with the current requirements of the Florida Building Code (FBC). Specifically, the spacing between verticals on the aluminum walkway railings do not comply with the requirements set forth in Chapter 1015.4 of the 2017 FBC (Building). However, the Association is not required to comply with the current FBC until the railings are replaced.

Photograph 12: Typical Aluminum Walkway Railings

The Association informed Velocity that Service Contracting Solutions provided an estimated cost of \$180,000 to replace all of the walkway railings. Based upon the current (assumed) age and condition of the railings, Velocity estimates the remaining useful life of the walkway railings to be approximately 8 years.

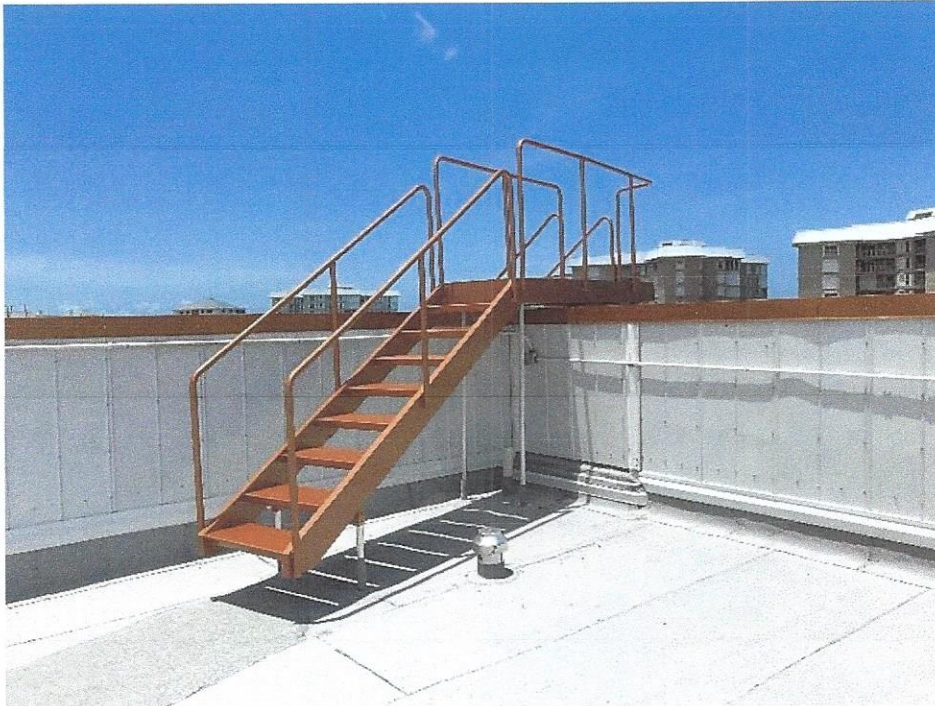
It is understood that the two access stairs/walkways on the roofs were installed in 2018 for a total cost of approximately \$23,000. The roof stairs/walkways were in excellent condition at the time of Velocity's site visit.

Photograph 13: Typical Roof Stairs/Walkways

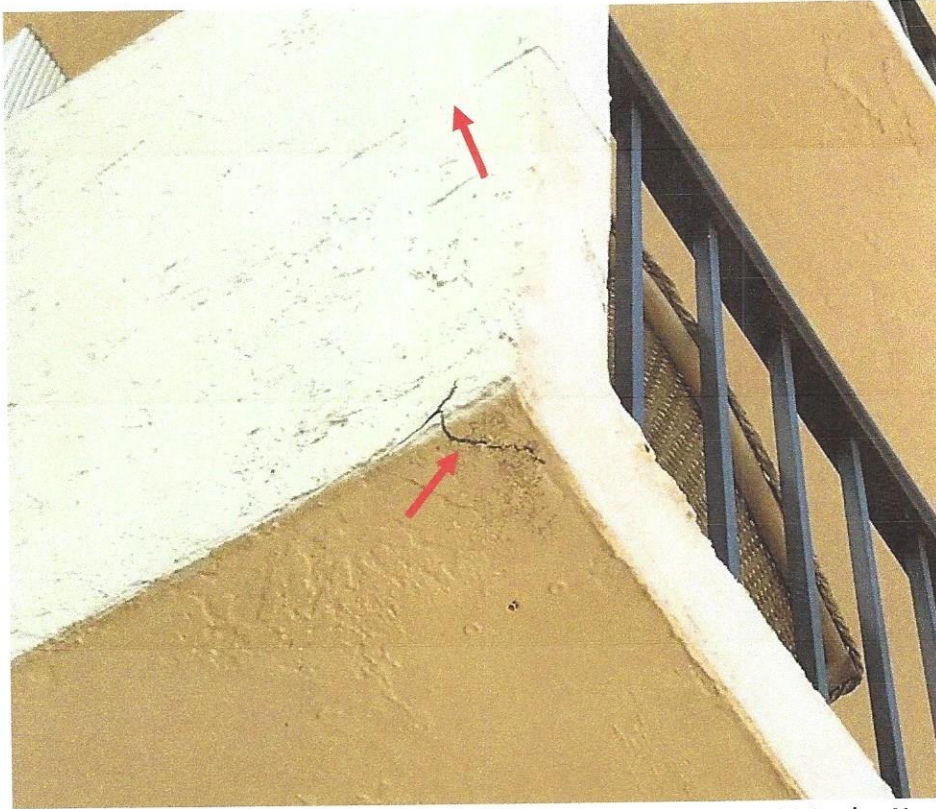
The concrete restoration reserve component consists of the cost to repair spalling concrete throughout the community. The Property Manager informed Velocity that structural repairs were performed in many areas throughout the buildings approximately 10 to 15 years ago. Additionally, it is understood that balcony surfaces were waterproofed in 2016 by Elias Brothers Group Painting and Contracting, Inc (Elias) for a total cost of \$55,719. Velocity observed the buildings from the ground during our site visit. Overall, the building structures appeared to be in good condition. However, Velocity observed 1 area of spalling/cracked concrete during our site visit at the corner of the balcony of Unit 201 in the north building. Subsequently, the Association retained Velocity to perform inspections of the buildings and balconies from a man-lift in order to identify other areas where concrete may be spalling/cracking. The results of Velocity's inspection have been issued in a Building Inspection Letter dated 10/3/18.

Photograph 17: Spalling/cracked concrete on balcony corner at Unit 201 in the North Building

Based upon the reported previous concrete restoration work performed throughout the buildings 10 to 15 years ago, and the results of Velocity's building inspections, it is recommended that the Association establish an allowance of \$200,000 every 15 years to fund any necessary concrete restoration or associated work. This cost should be considered approximate. Actual repair costs will depend on the extent of the damage, which cannot be identified until the destructive investigation recommended in Velocity's Building Inspection Letter is performed.

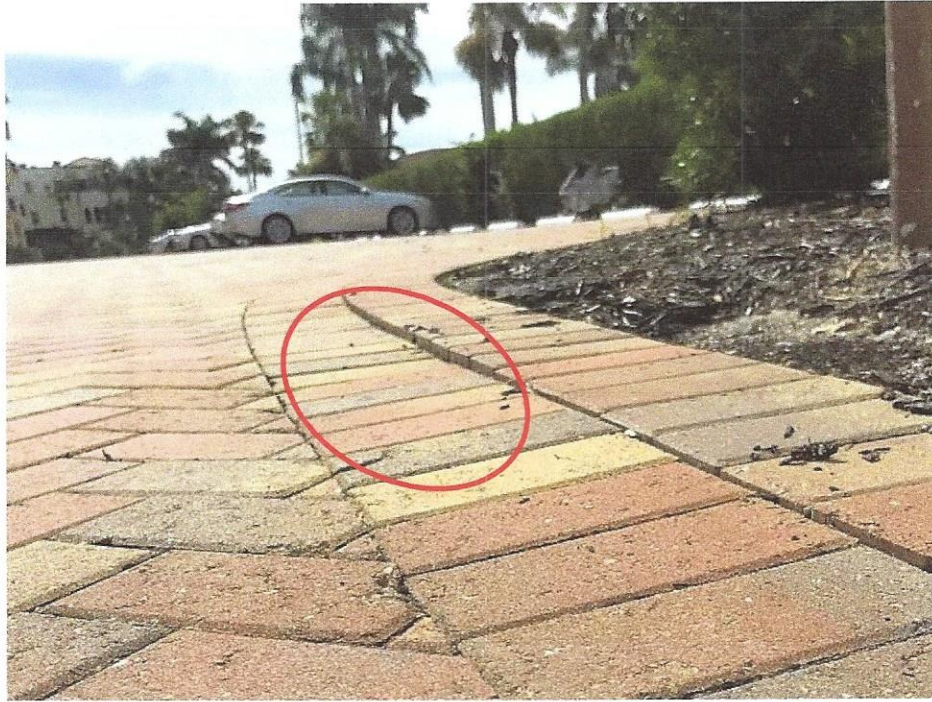
The pavers reserve component consists of the cost to replace the driveway and parking area pavers. The Property Manager informed Velocity that the pavers were installed in 2014. Localized cracked pavers and an area of depressed pavers at the southernmost entrance of the community were observed at the time of Velocity's site visit. Overall, the pavers appeared to be in good condition.

Significantly cracked or damaged pavers should be replaced, whereas minor cracking of pavers is cosmetic in nature and will have little effect on the useful life of the paver system. The observed depressed pavers have created an elevation difference and tripping hazard. The Americans with Disability Act Accessibility Guidelines (ADAAG) states in Section 303.2 that a maximum allowable elevation change of 1/4 inch shall be permitted. The elevation difference between the pavers was measured to be approximately 1/2 inch which does not comply with ADAAG guidelines. This area of pavers should be corrected.

Photograph 19: Localized area of depressed pavers at the southernmost entrance to the community

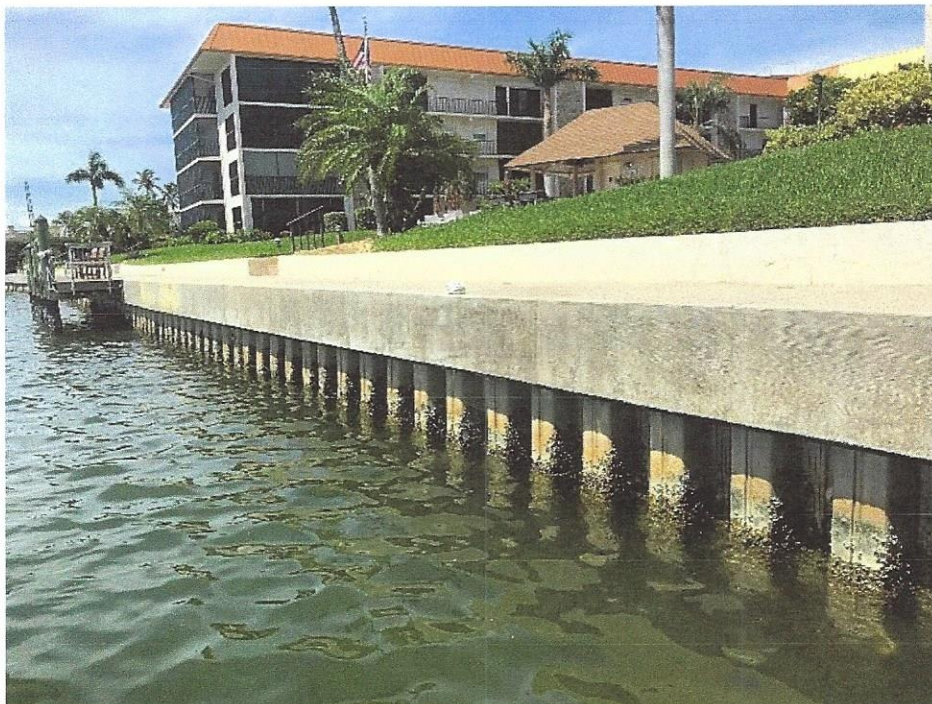
Photograph 20: Seawall

The seawall reserve component consists of the cost to replace the seawall located on the east side of the community. The seawall consists of corrugated steel sheet piles, a poured concrete cap/sidewalk, and helical pier anchor tie backs. The Property Manager informed Velocity that the seawall was replaced in the early 2000's. It is understood that maintenance to the seawall is performed routinely and is considered an operating expense. The seawall appeared to be in good overall condition for its age.

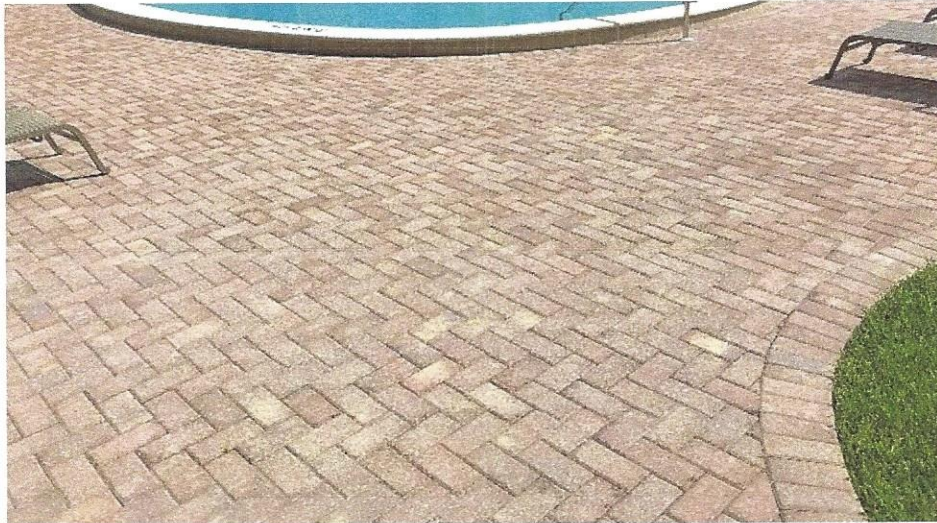
There are (thin) concrete pavers over concrete surrounding the swimming pool and on walkways throughout the property. The Property Manager informed Velocity that the pavers were last replaced in approximately 2008. At the time of Velocity's site visit, the pool deck and walkway pavers appeared to be in good overall condition with the exception of some localized cracking. Significantly cracked or damaged pavers should be replaced whereas minor cracking of pavers is cosmetic in nature and will have little effect on the useful life of the paver system.

Photograph 25: Typical Pool Deck and Walkway Pavers

It is anticipated that the pavers will be replaced approximately every 25 years.
