Inspection Report

The Bordeaux Club
Bordeaux Club-2900 Gulf Shore Blvd N
2900 Gulf Shore Blvd N
Naples, FL 34103

Site Overview

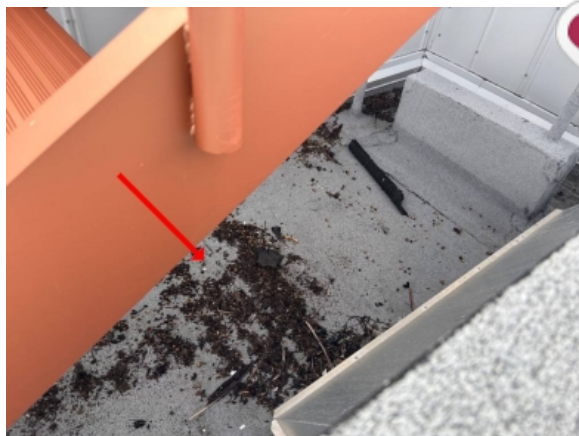
Surface - Debris

Loose debris has a high probability of blowing around on the roof and causing damage to the waterproofing membrane.

Remove loose debris from roof area and place in bag, and haul away.

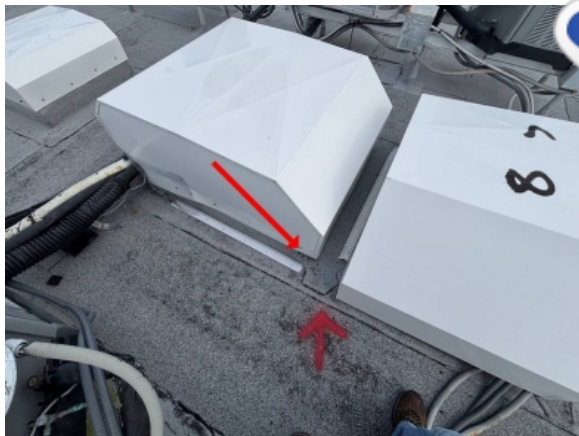
Fasteners - Failing/Missing (Emergency)

As the building moves and flexes the fasteners will loosen up and eventually back out completely resulting in water infiltration.

A new fastener, 1 size larger would be installed per industry standards to ensure a water tight seal.

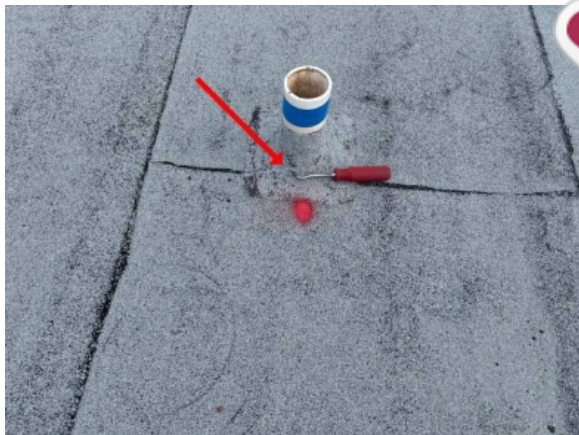
Penetration - Pipe flashing failure (Emergency)

Due to age, weathering, UV &/or improper installation the penetration flashing has failed.

The pipe penetration should be repaired/flashed properly for the type of roof system per minimum industry standards to ensure a water tight seal.

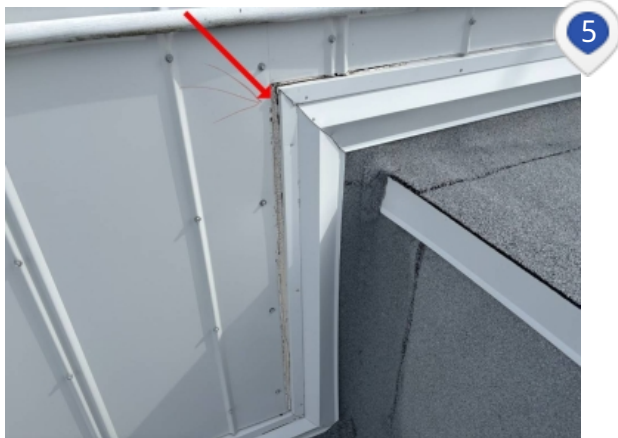
Caulking (Emergency)

Caulking is either non-existent or is in need of cleaning and applying.

Clean and prep area and apply new caulking.

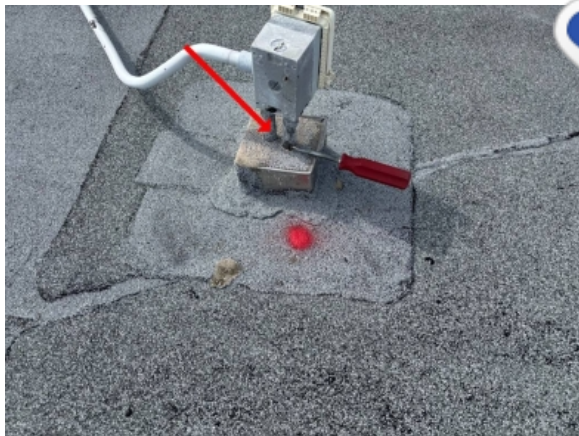
Penetrations - Pitch pan sealant failure (Emergency)

Over time, pitch pan fillers fail from age fatigue, cracking, shrinking, or separating from the pipes or conduits in the PP allowing water to enter the building.

When adding new mastic always dig out some of the existing mastic to provide better adhesion to the new material used to fill the pitch pan. Always apply new mastic in a pyramid fashion inside the pitch pan. In severe cases inert filler may be required to fill the bottom of the pitch pan and new pourable sealer applied vs. asphalt based mastic.

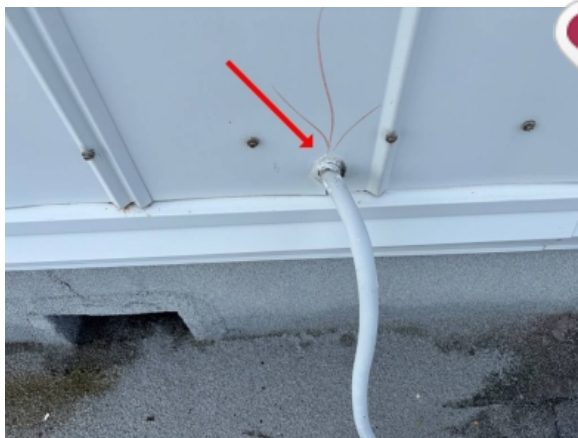
Penetrations - Caulking failure (Emergency)

Around the penetration the caulking or sealant has degraded and is in need of replacement/maintenance.

Cut out or remove the existing caulking/sealant, clean the area, and re-apply sealant to ensure water tightness.

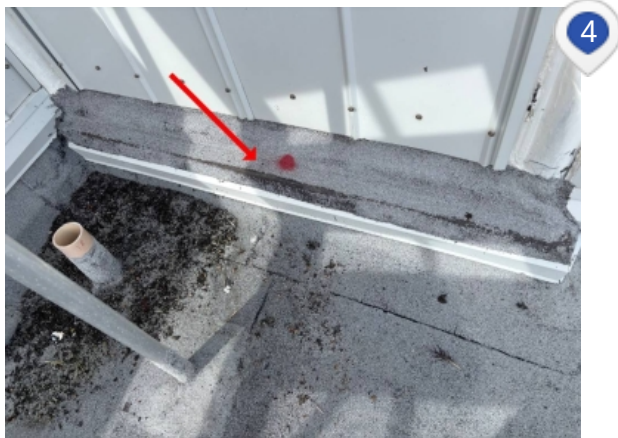
Membrane - Bare Spots

Bare spots are areas where the roof's protective surfacing is missing and the underlying asphalt materials are exposed to the sun. Bare spots can be caused by wind, foot traffic, or water. Resurfacing these areas are essential in protecting the existing roof system.

Clean the existing surface free from loose materials. Prime the roof as needed. Install new roof adhesive and surfacing to match existing.

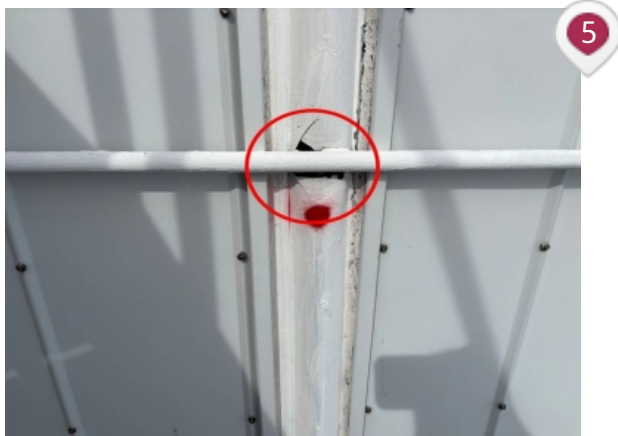
Expansion Joint Cut (Emergency)

Cut in rubber of expansion joint is allowing water in.

We will properly install patch to ensure water tightness.

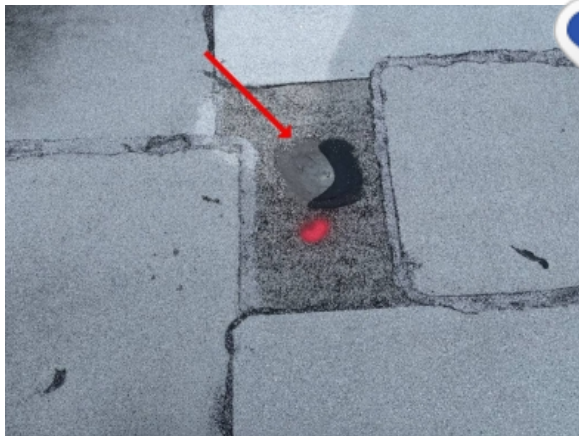
Membrane - Temporary Repair (Emergency)

Leak location detected in the roof system allowing water to enter into the building.

Clean the area to the best of our ability and apply water proof sealant to temporarily solve the roof leak.

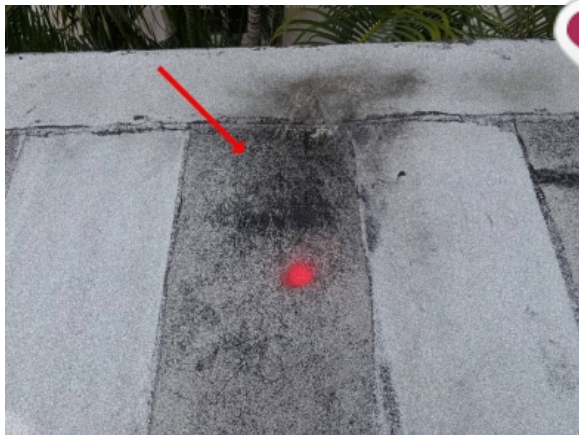
Membrane - Bare Spots

Bare spots are areas where the roof's protective surfacing is missing and the underlying asphalt materials are exposed to the sun. Bare spots can be caused by wind, foot traffic, or water. Resurfacing these areas are essential in protecting the existing roof system.

Clean the existing surface free from loose materials. Prime the roof as needed. Install new roof adhesive and surfacing to match existing.

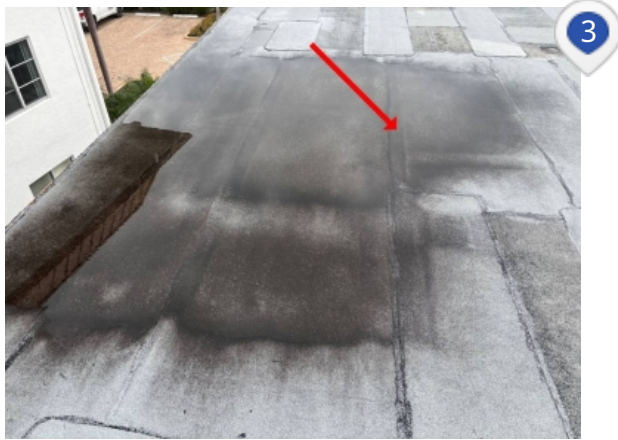
Reroof needed over office

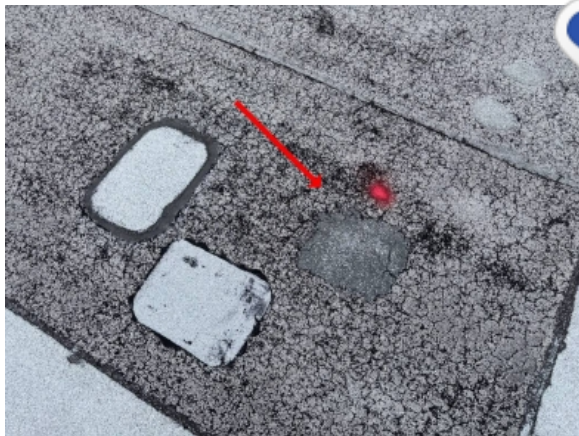
Membrane - Temporary Repair (Emergency)

Leak location detected in the roof system allowing water to enter into the building.

Clean the area to the best of our ability and apply water proof sealant to temporarily solve the roof leak.

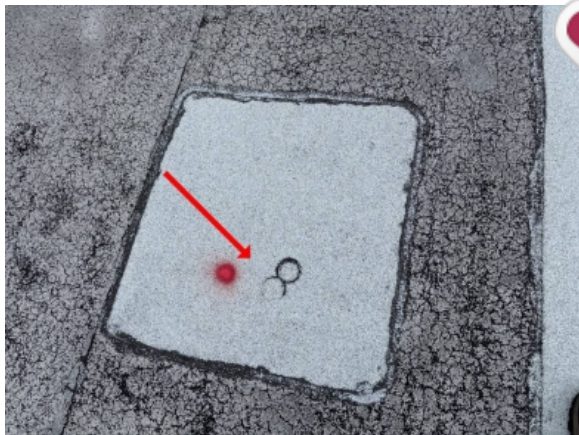
Membrane - Punctures/Rips/Tears (Emergency)

These deficiencies are typically caused by heavy foot traffic by other trades, careless mechanical work, careless installation processes or storm related weather events.

Clean and prep the area around the puncture, rip or tear and repair according to the existing type of roof system meeting the minimum industry standards for the type of repair needed.
