## STRUCTURAL INTEGRITY RESERVE STUDY REPORT

Bordeaux Club  
2900 Gulf Shore Boulevard N.  
Naples, Collier County, Florida  
Velocity Project Number: 23-480

Date: January 29, 2025

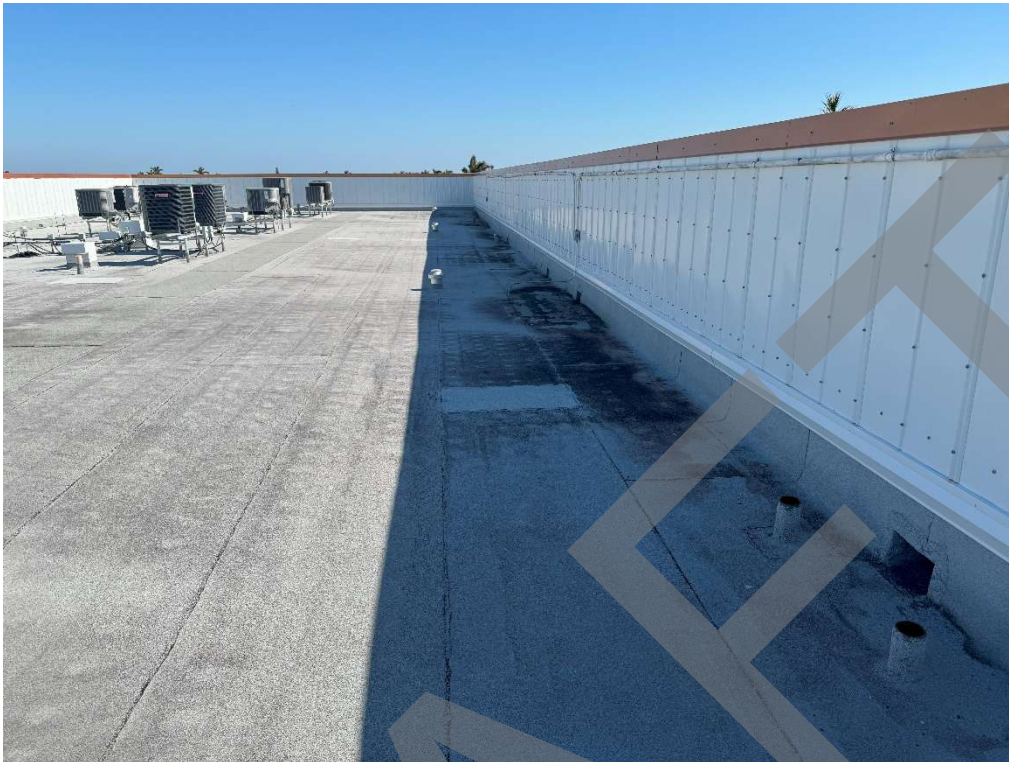
Based on provided information, previous conversations with the Property Manager, and Velocity's 2018 Reserve Study Report, West Coast Roofing and Contracting, Inc. (West Coast) replaced the North and South buildings' modified bitumen flat roofs in 2018 for a total cost of \$236,000. The roofs of the North and South buildings were in good overall condition, consistent with their age. Based on review of City of Naples permit documents, the replacement of the West building's roof was completed in April 2021 and was in excellent condition at the time of Velocity's inspection. Velocity estimates the current replacement costs of the flat roofs to be \$144,300 to \$146,250 per building (\$1,950.00 per square) and the remaining useful lives are approximately 12 to 15 years. Replacement costs are based upon the building's roof square footage and experience with similar projects. It is anticipated that the modified bitumen roofing system will be replaced every 20 years,

Photo 1: General condition of flat roof – North Building

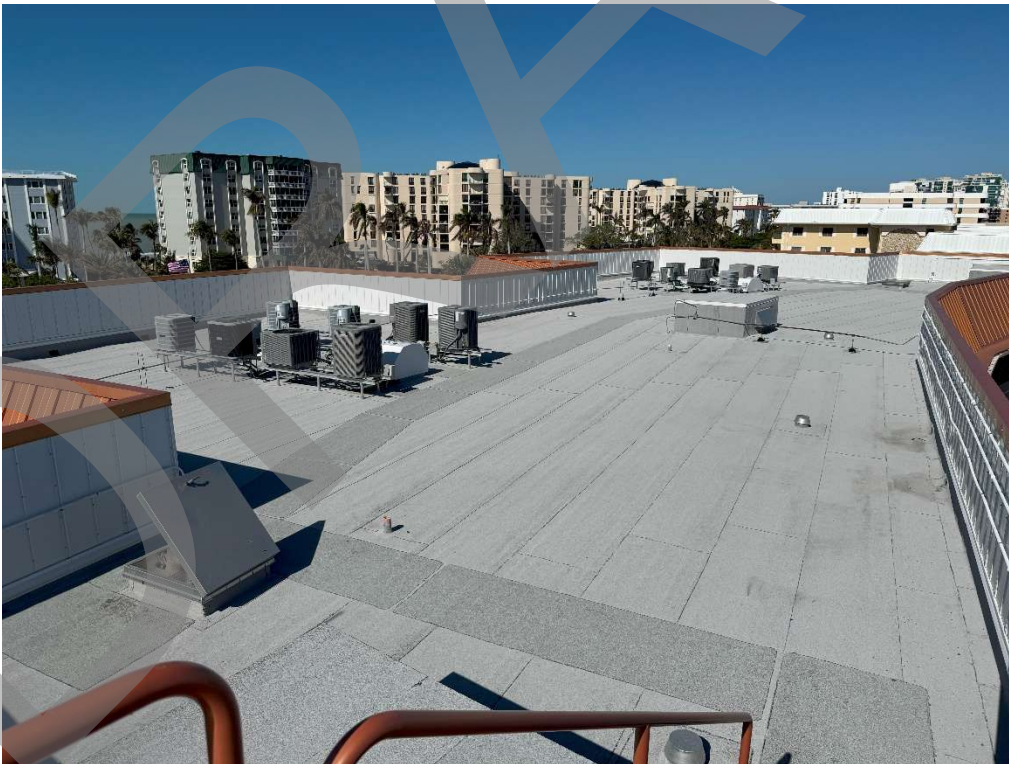
Photo 2: General condition of flat roof – West Building

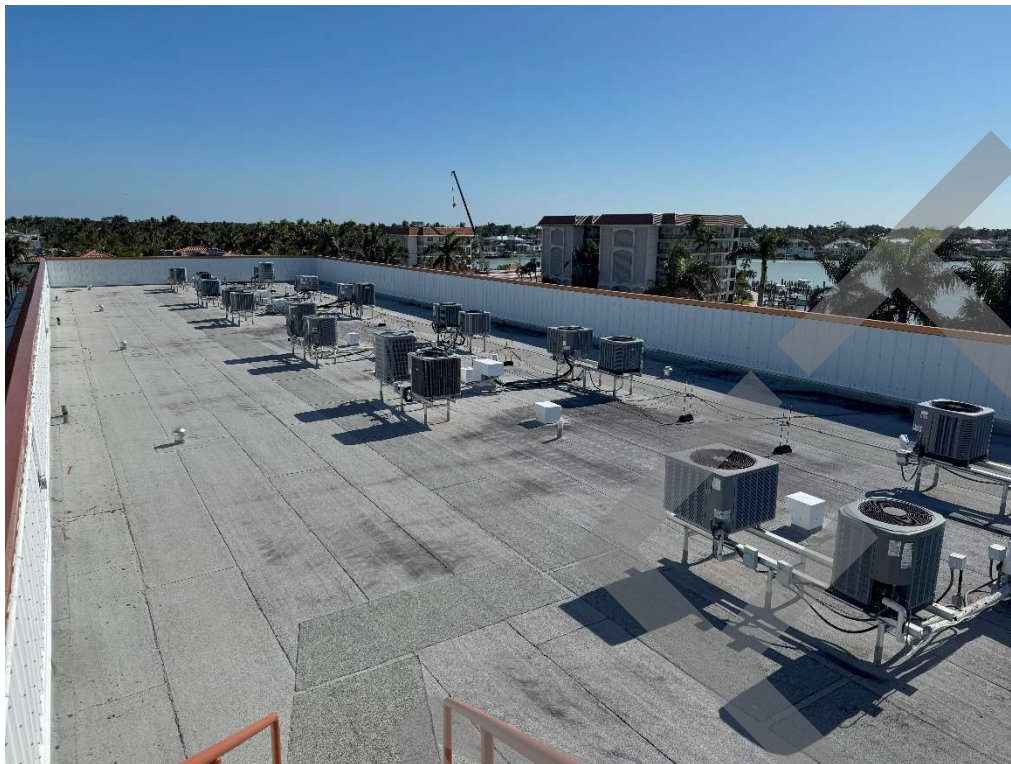
Photo 3: General condition of flat roof – South building

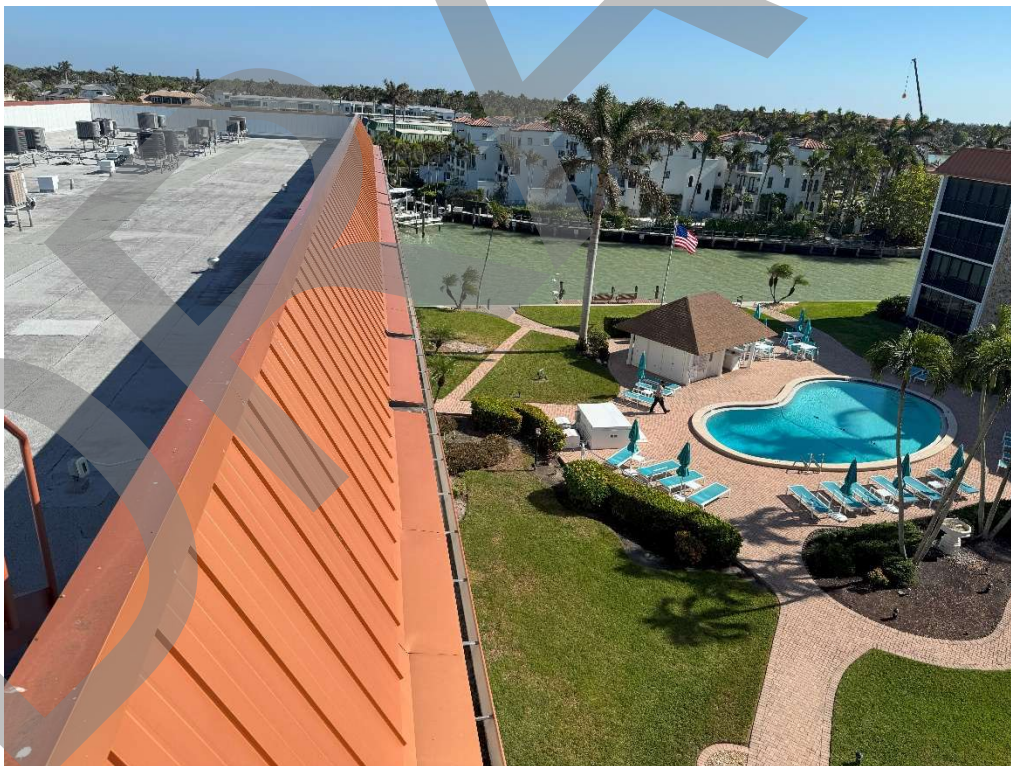
Crowther Roofing and Sheet Metal of Florida, Inc. (Crowther) replaced the metal mansard roofs located along the perimeter of all the buildings in 2005 for a total cost of \$105,360. The standing seam metal roof panels on the mansard roofs appeared to be in overall good condition, consistent with their age. Velocity observed areas of mold/mildew build up along the north and south building roofs near the roof scuppers. Roof inspections and roof cleaning are recommended as part of ongoing maintenance. Velocity estimates the current replacement cost of the Mansard roofs to be approximately \$308,700 (\$2,450.00 per square) and the remaining useful life is 12 years. Replacement costs are based upon the building's roof square footage and experience with similar projects. Depending on the quality of materials and workmanship, standing seam metal mansard roofs can last 30 to 40 years.

Photo 4: General condition of standing seam metal mansard roofs

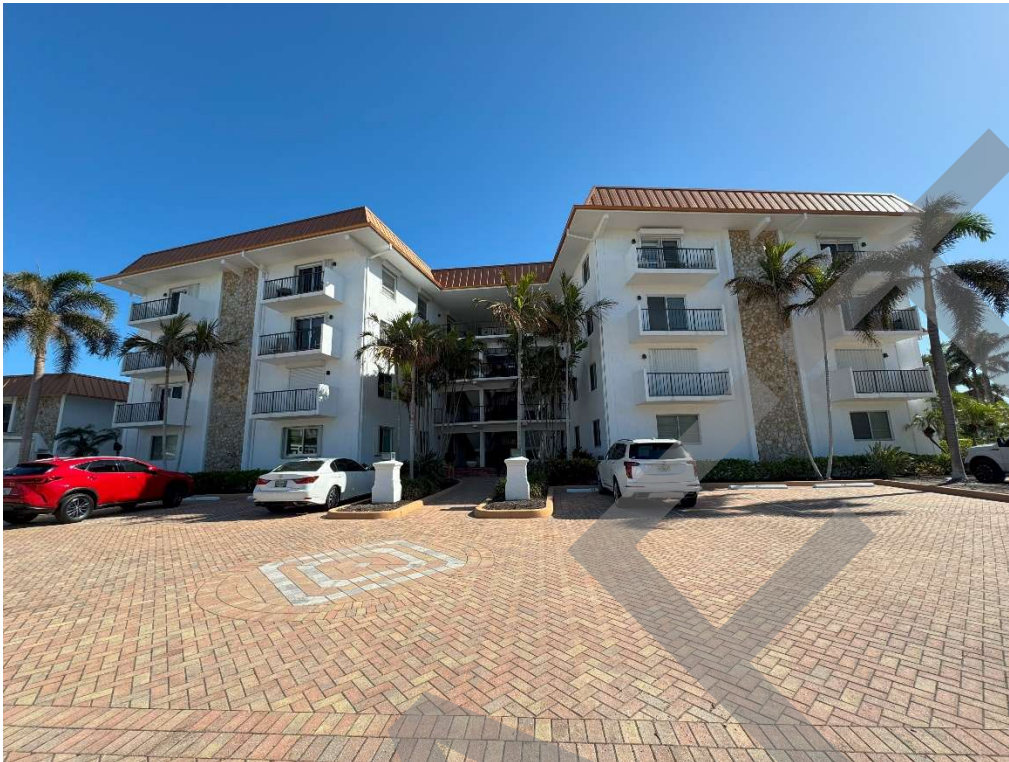
Photo 5: General condition exterior building.

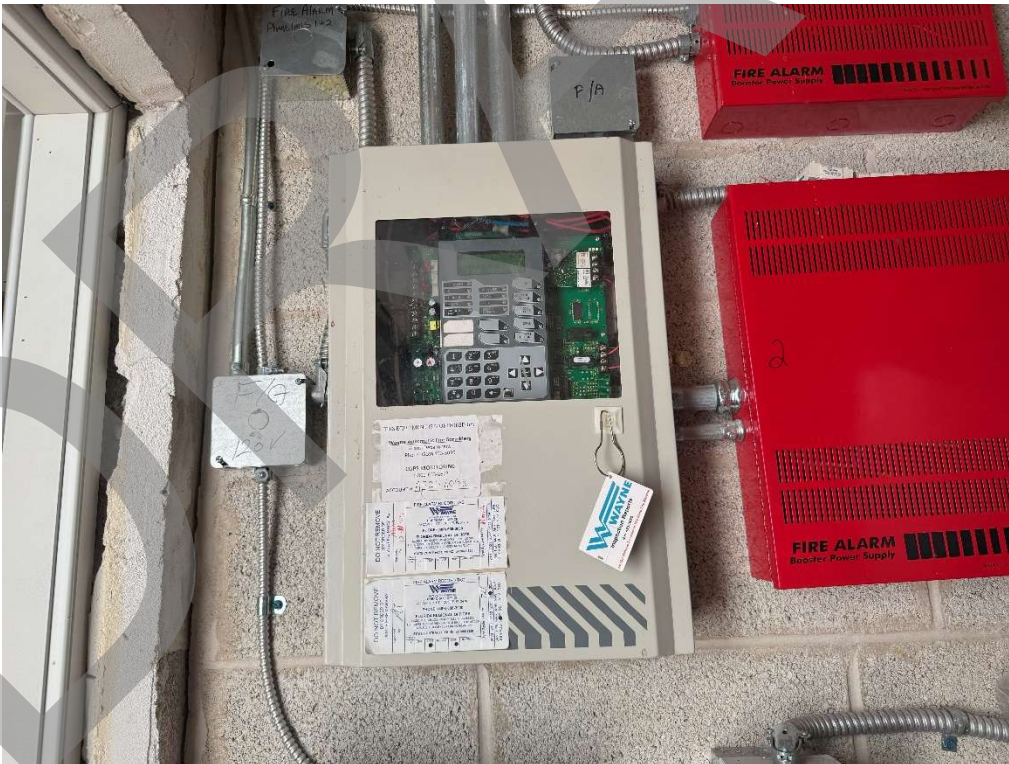
Velocity spoke with Mr. Eddie Passmore and Mr. Phillip Rodgers with Wayne Automatic, the Association's fire alarm service contractor, to obtain additional information regarding the condition, remaining useful life, and estimated replacement costs of the fire protection systems. It is understood that the fire alarm control panel (FACP) was last replaced in 2009. Mr. Passmore stated that the current fire protection systems are functioning properly and in good condition, and provided an approximate useful life of 10-15 years for the FACP. However, the onsite FACP inspection log indicates that on 12/11/24 there was an internal fault and a note recommending replacement. Mr. Rodgers provided Velocity with an estimated cost of \$15,000 to replace the FACP.

Based on the information presented above, the FACP appears to be nearing or at the end of its useful life and should be replaced. It is important to also note that the Authority Having Jurisdiction (AHJ) and local fire district may or may not require a modernization of the existing fire protection systems. Until additional information becomes available, Velocity has included a system modernization line item for the fire protections systems. Mr. Rodgers provided an estimated cost of \$80,000 to \$100,000 to upgrade/modernize the fire protections systems throughout the buildings to comply with the most recent building codes/regulations. Wayne Automatic informed Velocity that a modernization project would generally consist of replacing the FACP, associated communicators, smoke detection systems, alarms, pull stations, and installing low frequency sounders in the unit bedrooms. Once the system modernization is complete, if determined necessary, this line item may be removed and the SIRS updated.

Photo 6: General condition of the fire alarm control system

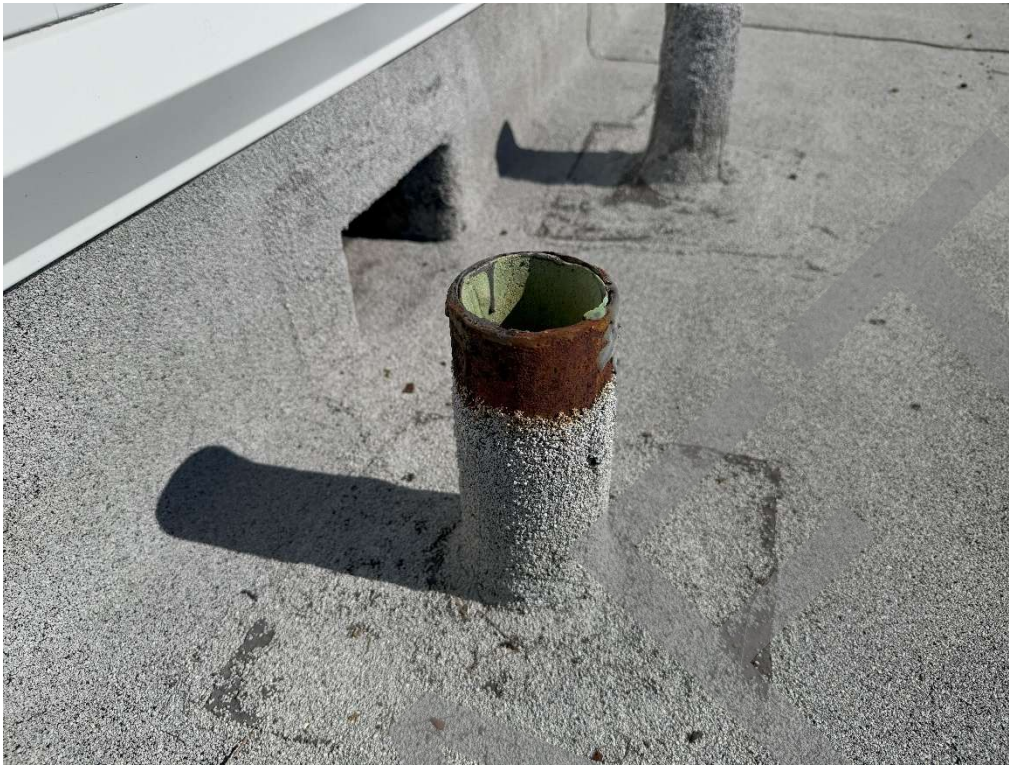
Photo 7: Ventilation Pipe with lining

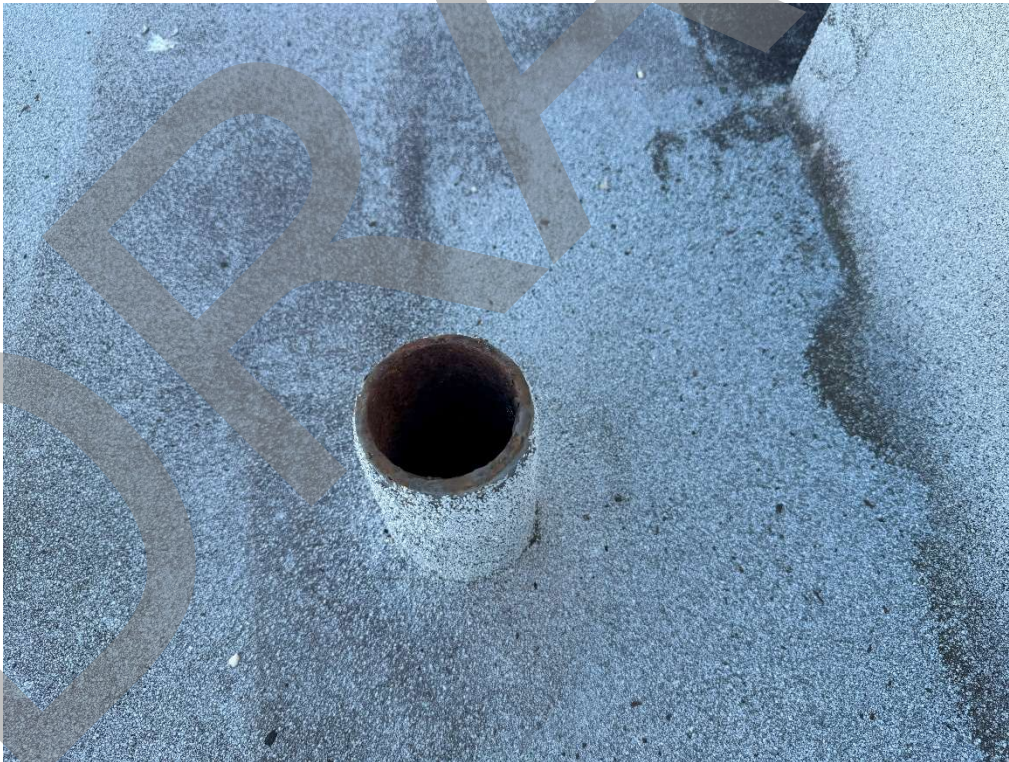
It should be noted that the provided Questionnaire states all cast-iron waste/ventilation pipe stacks have been relined, however, Velocity observed some cast-iron ventilation pipe stacks along the North Building that do not appear to have been relined (see Appendix 3 – Project Photos). Based on Velocity's observations, there are above ground sanitary pipes or ventilation stacks that have not been re-lined and it is assumed that this pipe is also in poor condition (based on the age and relining currently underway). Based on this information and the age of the cast-iron pipe (51 years), Velocity recommends that the Association retain a licensed plumber to inspect all remaining or un-lined cast-iron pipe and determine which pipe requires lining or repairs. Additionally, a licensed plumbing or mechanical professional should evaluate the domestic water lines, determine their remaining useful life, and if any major repairs or replacements should be anticipated. Until additional information becomes available, Velocity has included further pipe relining in the SIRS schedule. It is anticipated that the building's cast-iron pipe and associated lining has a remaining useful life that exceeds 25 years. Therefore, upon completion of relining all corroded or deteriorated cast-iron pipe, the Cast Iron Pipe Relining line item may be removed and this SIRS updated.

Photo 8: Ventilation Pipe without lining

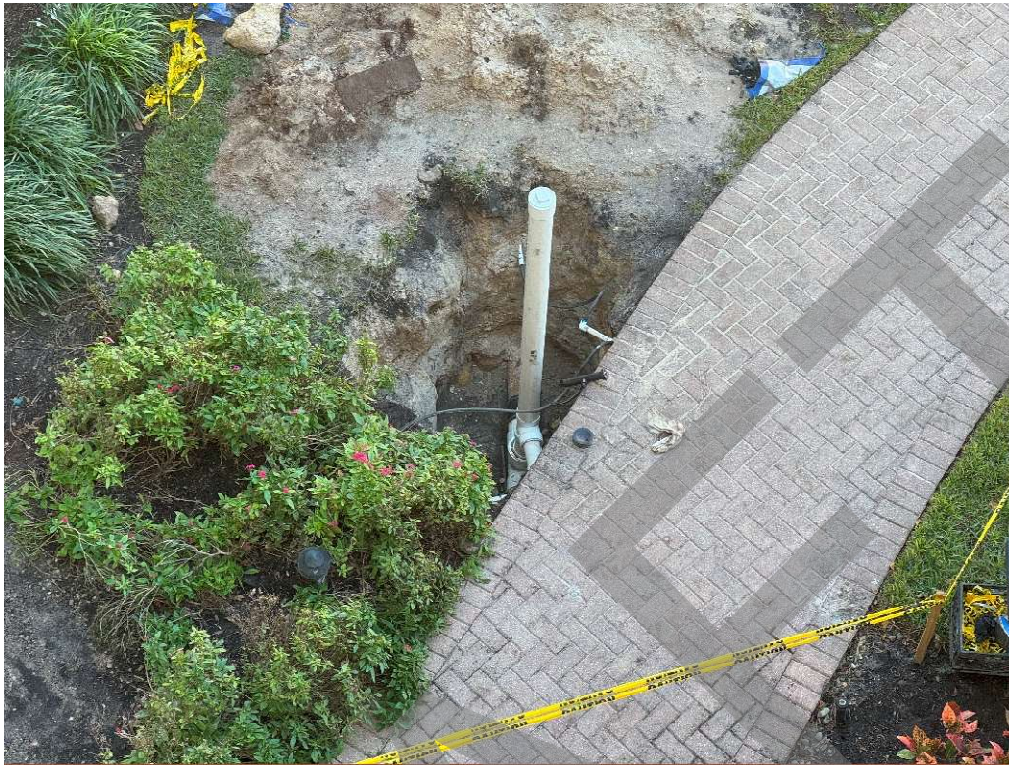
The Association provided Velocity with an authorized proposal, dated 08/27/2024, from Pipe Restoration Solutions, Inc. (PRS) to perform required repairs and replacement of deteriorated cast-iron pipe. The scope of the proposed work generally consisted of installing a Cured-In-Place Pipe (CIPP) lining along the underground main drain and underground lateral runs, correcting a misaligned pipe at Unit 103, and replacing any necessary

pipe under the pool pavilion located at the center of the property. PRS is currently performing the required repairs for a total cost of \$199,905.

Photo 9: Ongoing repairs of underground plumbing systems

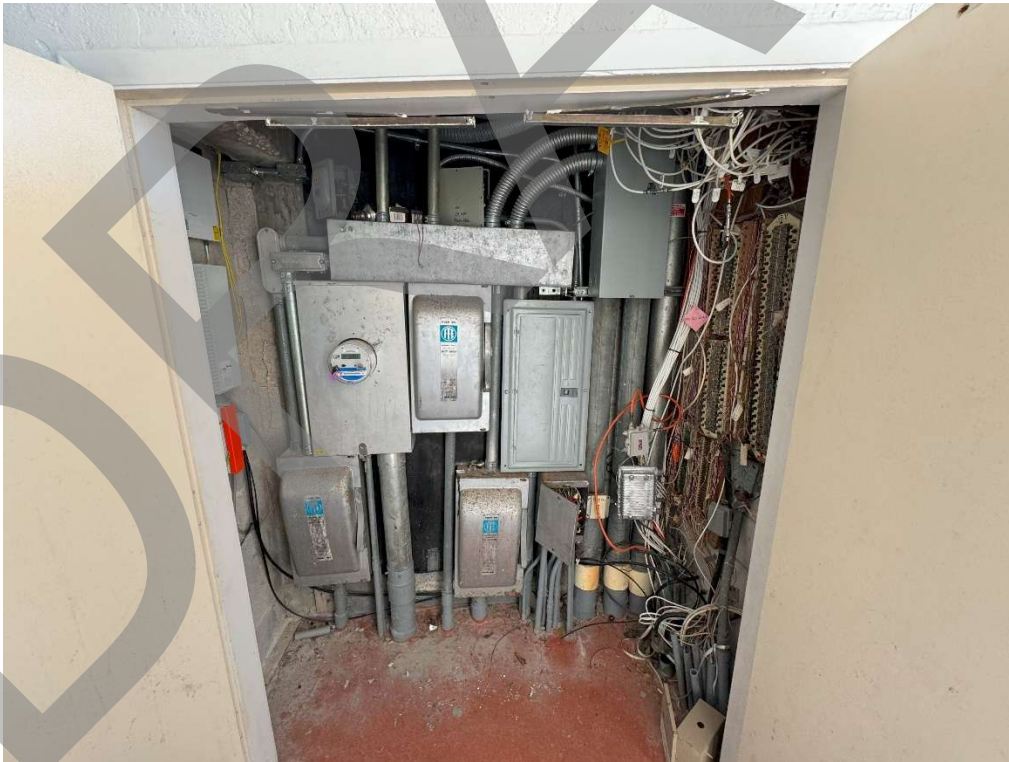
Based on Velocity's observations and conversations with the Property Manager, it appears that the current electrical system is from original construction. The systems appeared to be functioning properly and in overall fair to good condition. There was some rust and corrosion observed on switch panel housings. It is important to note that the electrical system is currently approximately 51 years old and service panels, wiring/conduit, and electrical accessories do not have an indefinite life. The useful life of these components depends on many factors including but not limited to the quality of original installation and material, exposure to heat and moisture, mechanical stress, etc. Due to the age of the electrical service panels and the typical useful life of electrical equipment, Velocity recommends that the Association reserve to replace original components over time. It is also recommended that the Association retain a licensed electrical professional to further evaluate the current system and determine if major replacements will be required. Should major repairs or replacement be required, Velocity should be notified and this SIRS updated.

Photo 10: General condition of electrical equipment

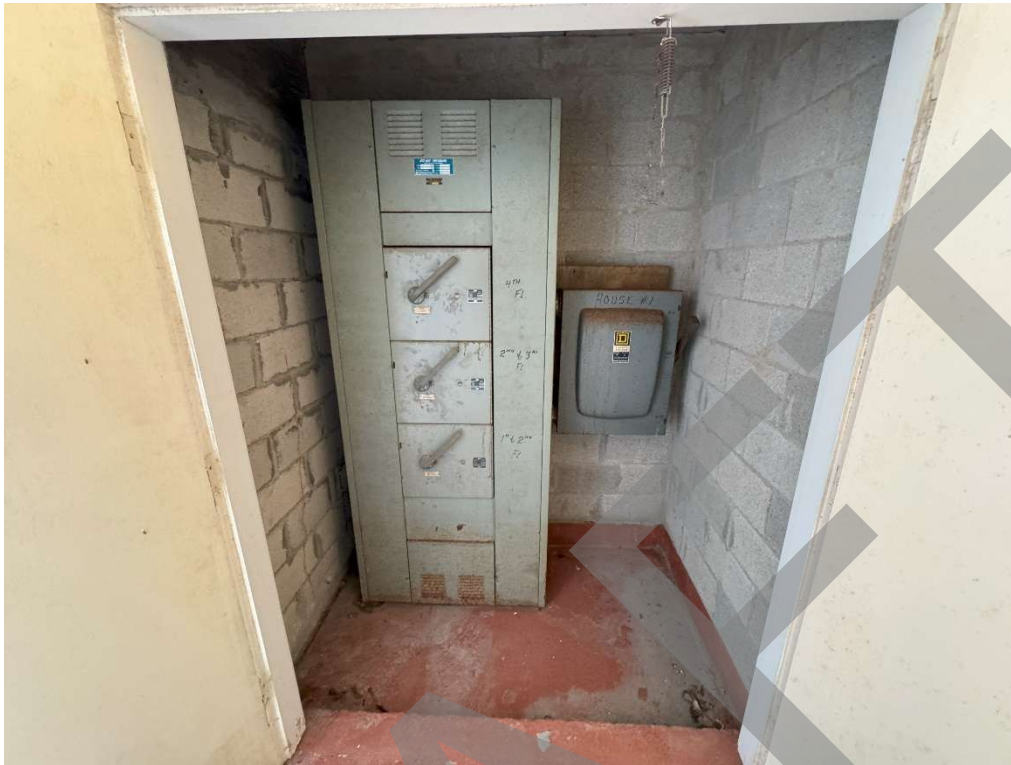
Photo 11: General condition of electrical equipment

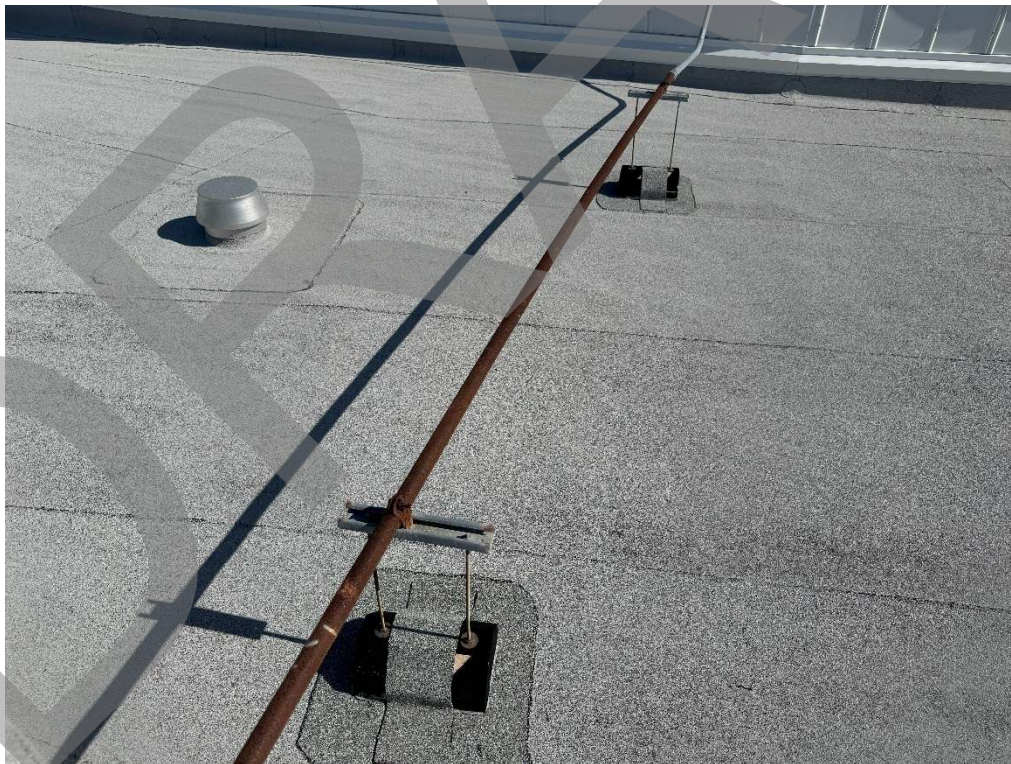
Additionally, Velocity observed rusted electrical conduit and junction boxes for the HVAC equipment on the roof. The rusting conduit and junction boxes should be replaced.

Photo 12: Rusty electrical conduit on the roof

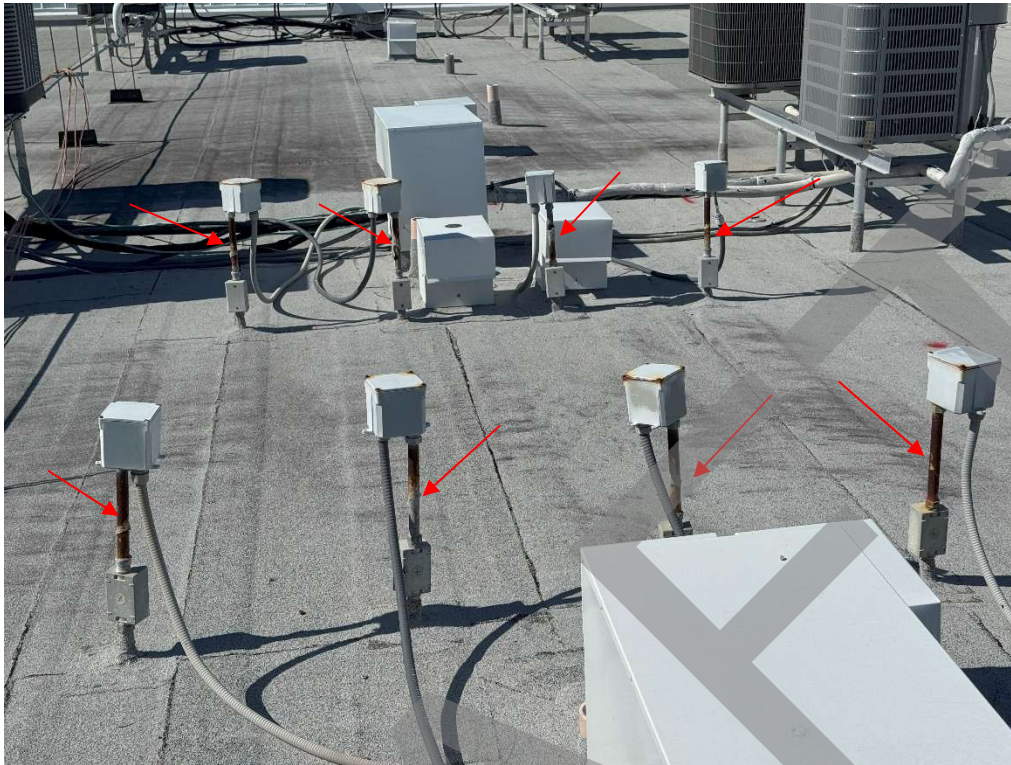
Photo 13: Rusted electrical conduit on the roof

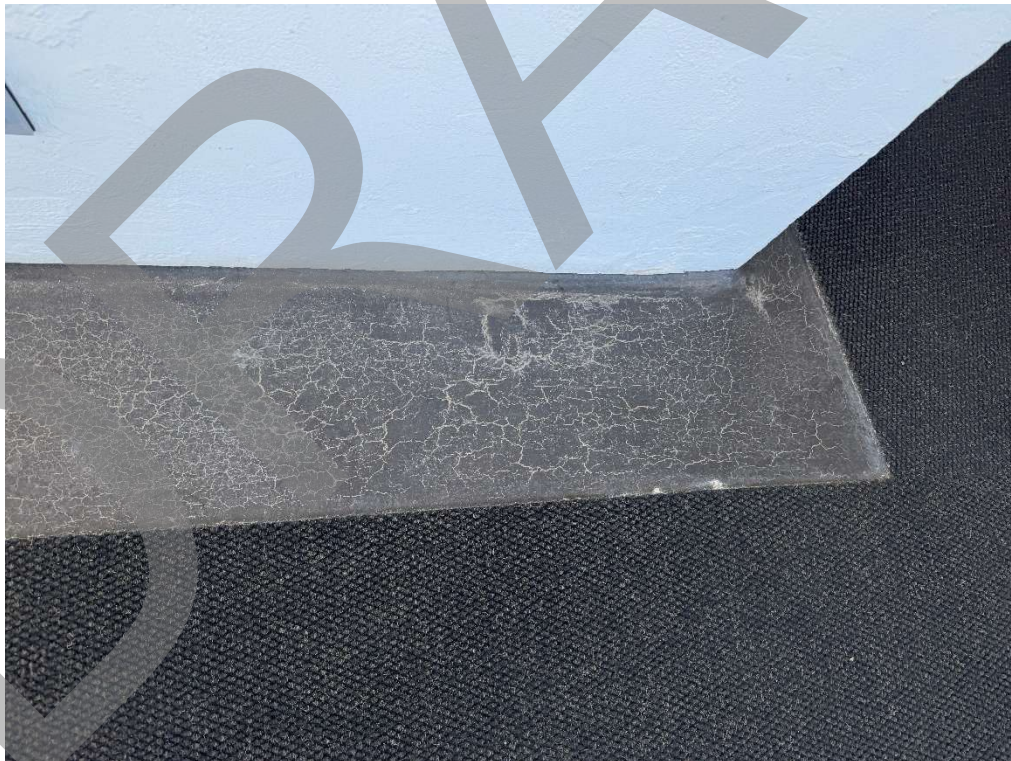
There is carpet installed on the common area walkways and stairs. Below the carpet, it appears that walkways and stairs have been painted or coated with an acrylic or similarly based product. The paint or coating is cracked and failing in many areas. Carpet acts like a sponge, contributes significantly to water intrusion, and should not be installed on exterior concrete slabs. Acrylic or paint products on slabs may offer some protection from water intrusion; however, they are not comparable to a waterproof coating system. Without a waterproof coating or protection from water intrusion, spalling can occur due to excess moisture in the concrete and subsequent corrosion of the embedded steel reinforcement. Velocity recommends that the Association perform a waterproofing project for the elevated walkways and stairs. This project is likely to include removal of all floor finishes (carpeting and coatings), and application of a high-performance waterproofing system. Based on the poor condition of the walkway aluminum handrails, the Association should consider replacing them at the same time. The useful life of waterproofing can vary significantly (approximately 5 to 20 years), depending on the

Photo 14: Typical failing coating along elevated walkway slabs

product that is applied, and maintenance performed over the life of the system. The estimated cost to waterproof the walkways is approximately \$212,000 (\$20.00 per square foot). It is understood that the Association is planning on performing this project in conjunction with a walkway handrail replacement project in 2026. Velocity has estimated the waterproofing project costs based upon the estimated square footage and experience with similar projects.

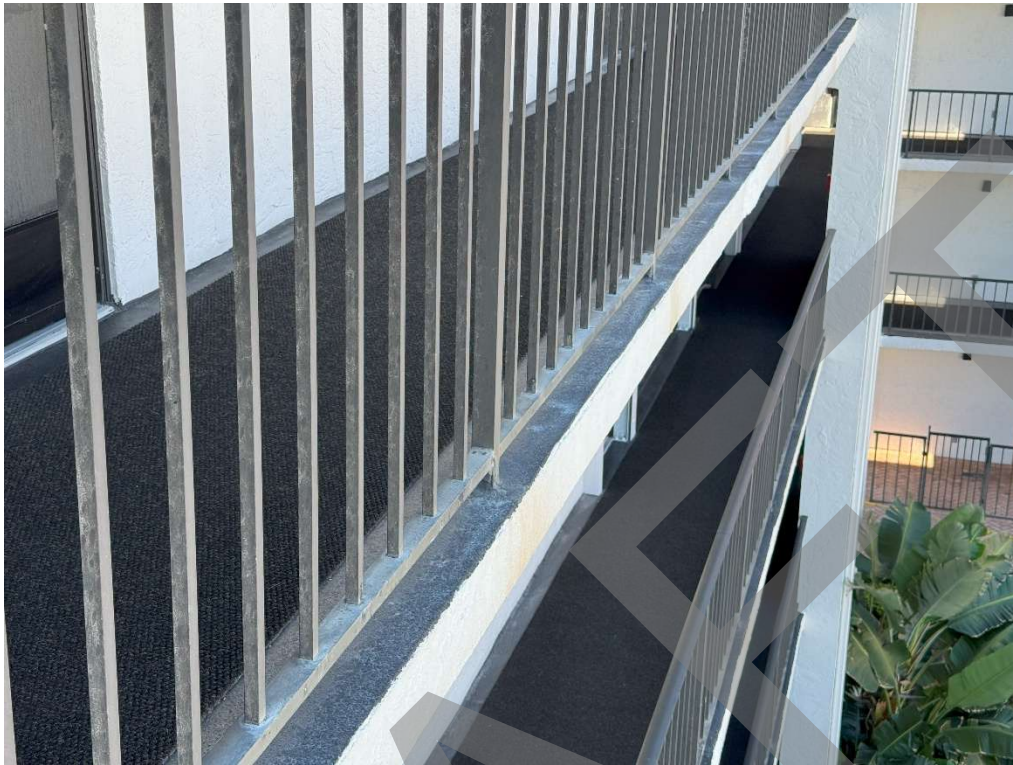
Photo 15: Rust stains along elevated walkway slab edges

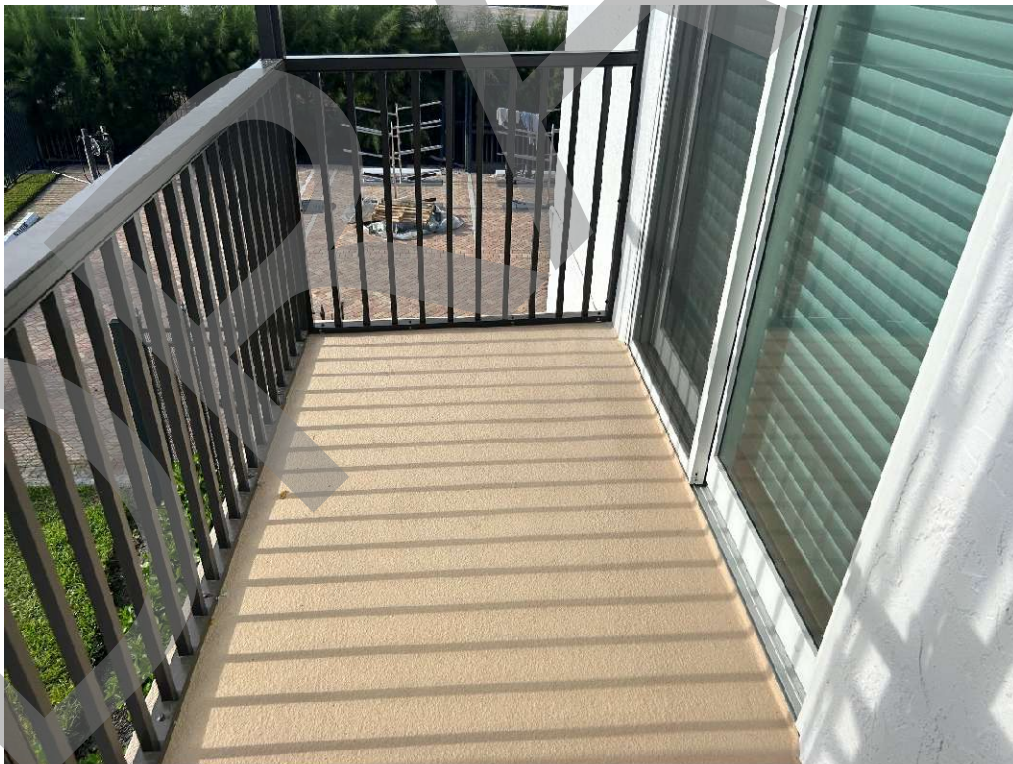
The Association provided Velocity with an Invoice from Elias Brothers Group Painting and Contracting, Inc. (Elias), dated 06/29/2016, to waterproof or recoat a total of 45 balcony slabs. The scope of work performed generally consisted of stripping existing waterproofing/coatings from balcony slabs, concrete crack repairs, application of a new waterproof membrane, recoating balcony slabs, and painting to match existing. Elias performed this work for a total cost of \$55,719. There have been no reports of known issues with the previously installed waterproofing membranes and based on Velocity's limited observations, they appear to be in good condition. As noted in Section 1.1, RL James installed a new Sikalastic waterproofing system along the east elevation unit balconies of the north, south and west buildings and the north balcony of Unit 416 as a part of the 2024 concrete repair project. This waterproofing is new and in excellent condition.

Photo 16: New Waterproofing installed on balconies.

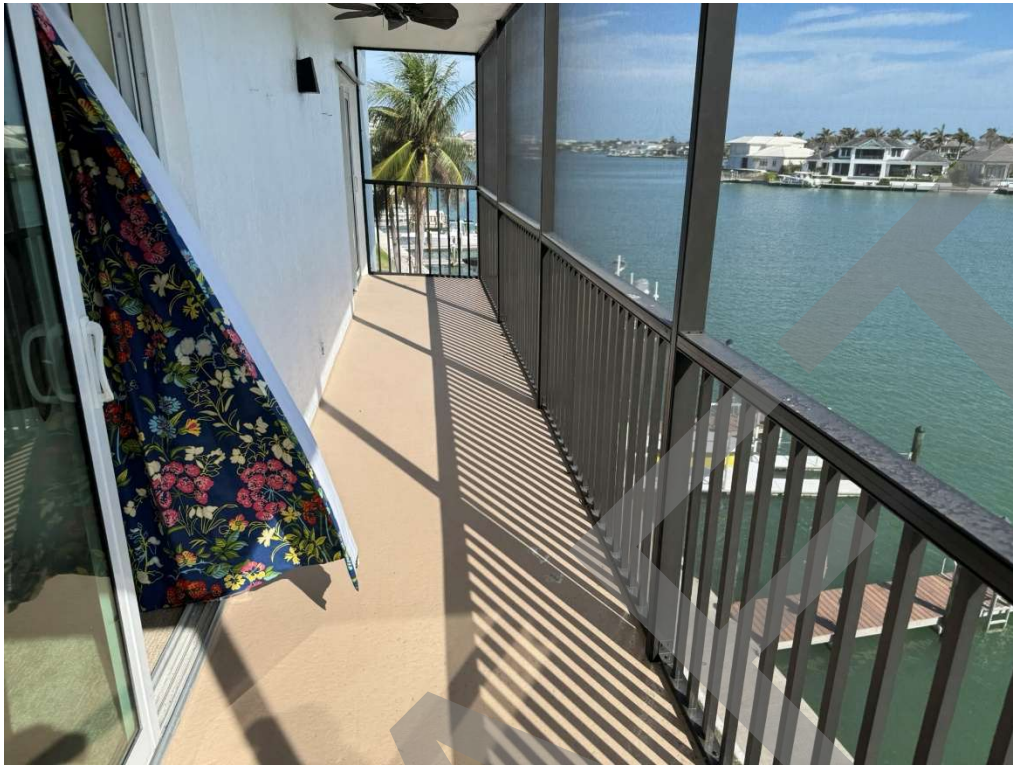
The aluminum screen enclosures on balconies all replaced as part of the 2024 repair project. These aluminum enclosures are expected to have a useful life that exceeds 25 years. Therefore, replacement of aluminum screen enclosures has been excluded from this SIRS. As noted in Section 2.6, the aluminum handrails are assumed to be original (51 years old), are in poor condition, and replacement is recommended. Therefore, an Aluminum Handrail Replacement Line Item has been included in the SIRS schedule. It is recommended that this is performed in conjunction with a walkway waterproofing project in 2026. Velocity estimates the cost to replace the aluminum handrails along the elevated walkways to be \$250,000.

Photo 17: Typical New Aluminum enclosure

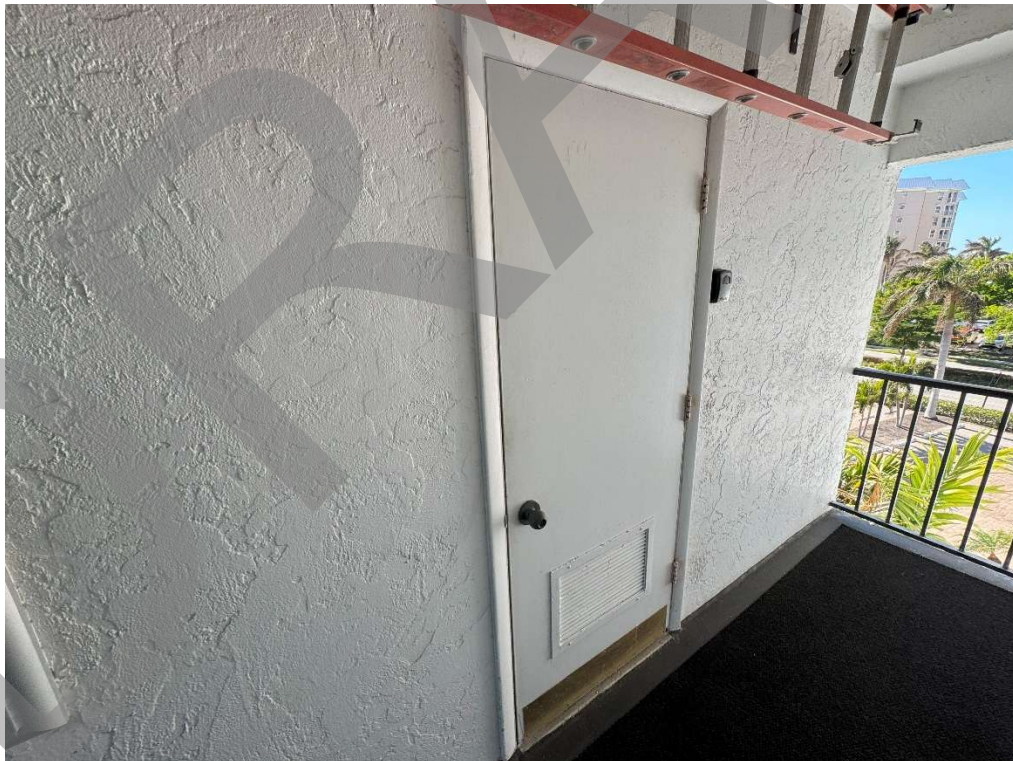
The doors were in overall good condition at the time of Velocity's inspection. Velocity has included a deferred maintenance expense of \$100,000 every 20 years to account for door replacement on an as needed basis. Windows throughout the 4-story buildings are the responsibility of the individual unit owners and are therefore excluded from this SIRS. The remaining windows are installed at the manager's building, maintenance building, and pool pavilion are not required to be included in this SIRS.

Photo 18: Typical Condition of unit storage doors

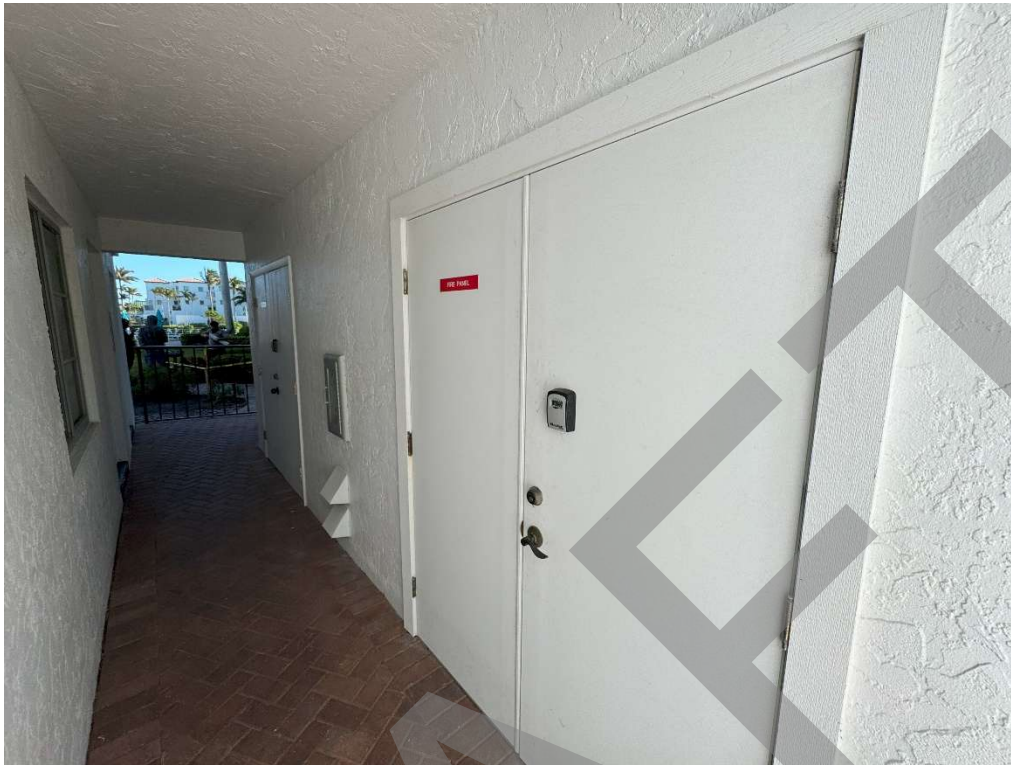
Photo 19: Typical condition of service equipment doors
