STRUCTURAL INTEGRITY RESERVE STUDY REPORT

Bordeaux Club

Velocity Project Number: 23-480

Date: November 13, 2025

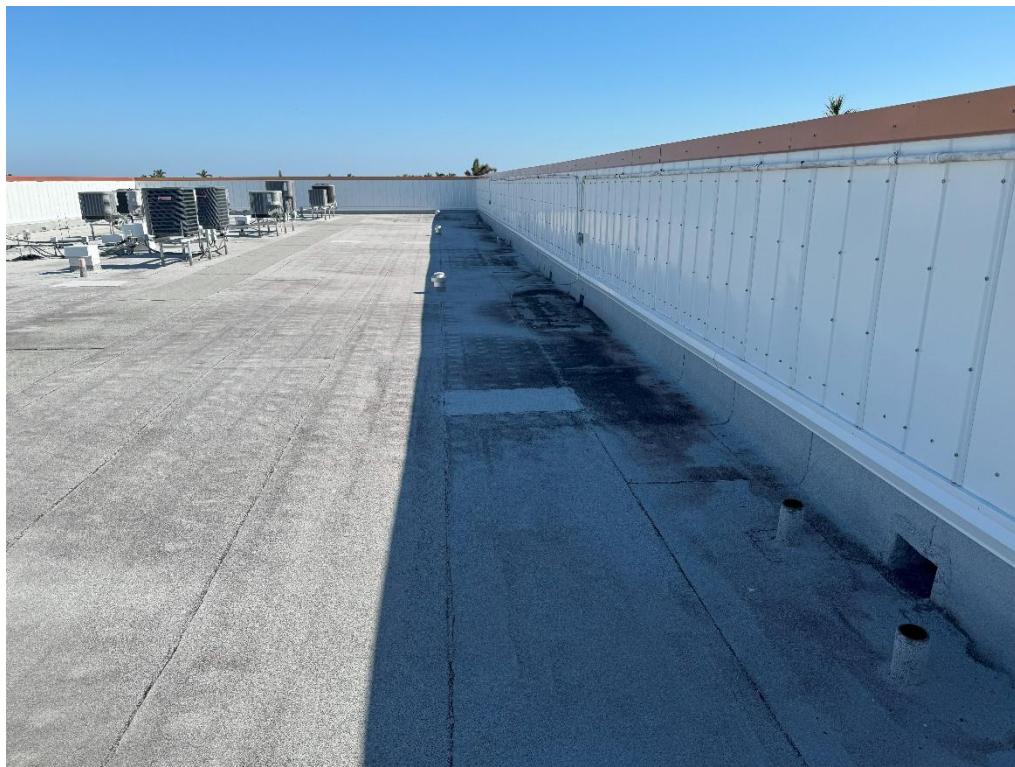
Photo 1: General condition of flat roof – North Building

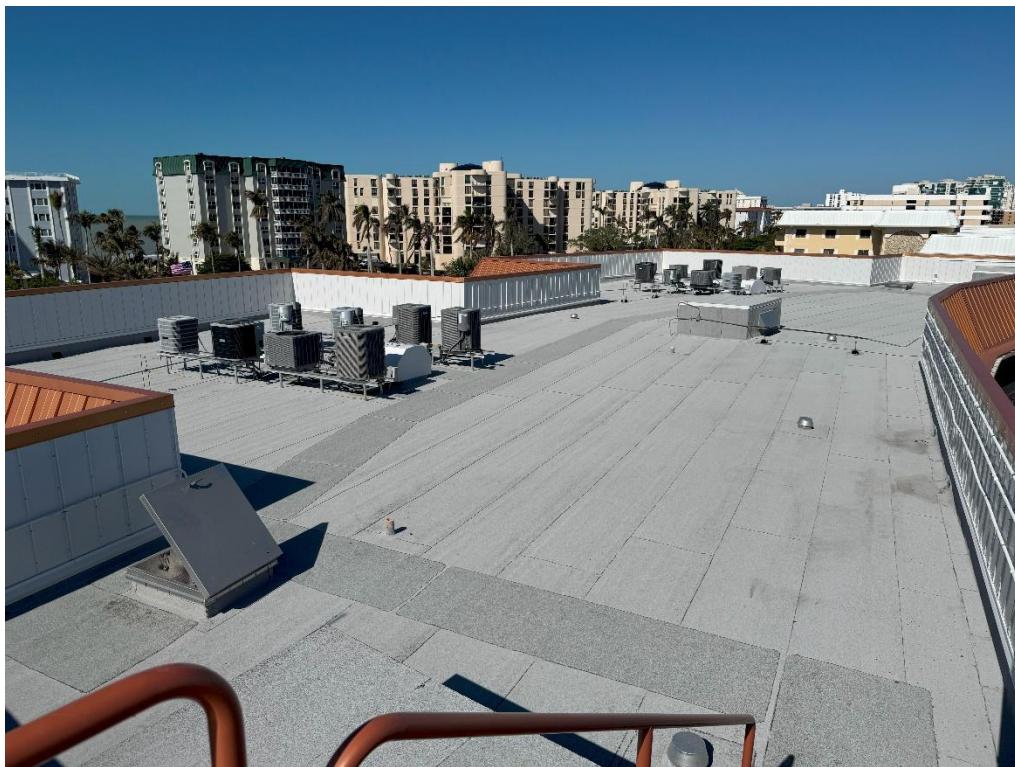
Photo 2: General condition of flat roof – West Building

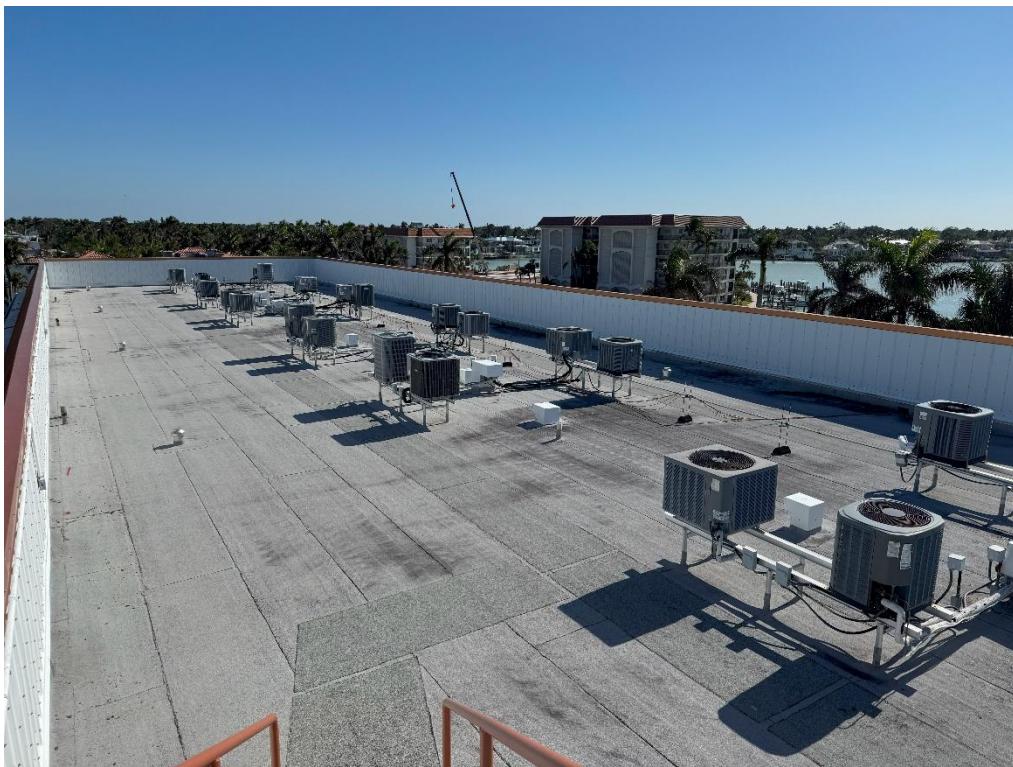
Photo 3: General condition of flat roof – South building

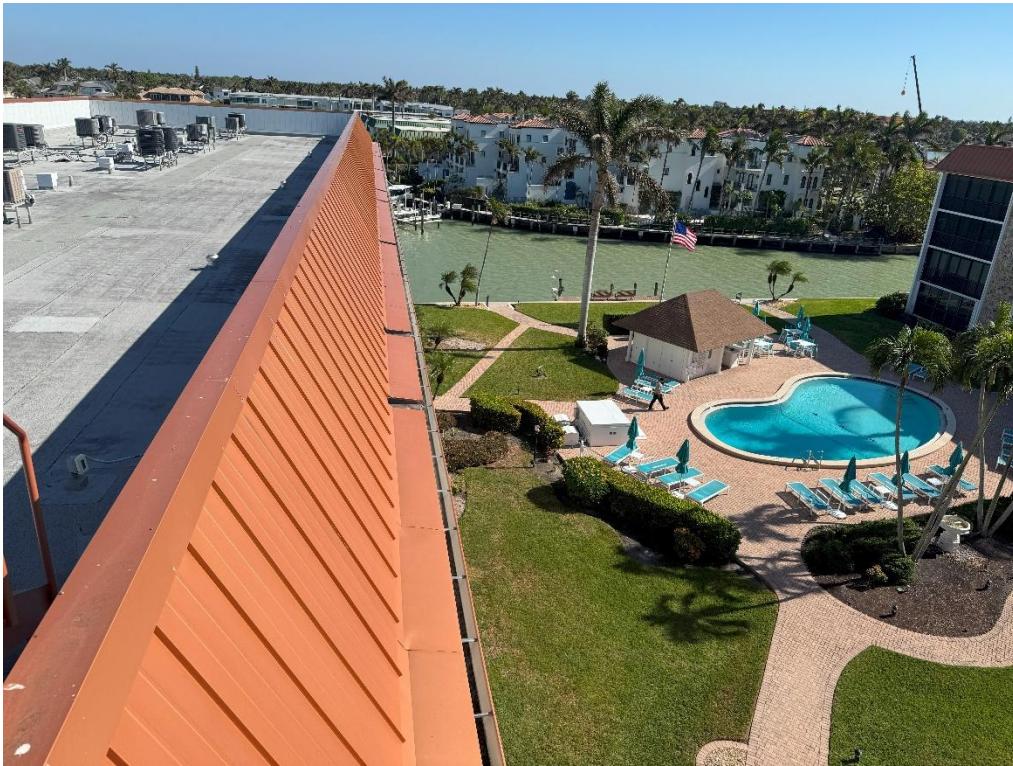
Crowther Roofing and Sheet Metal of Florida, Inc. (Crowther) replaced the metal mansard roofs located along the perimeter of all the buildings in 2005 for a total cost of \$105,360. The standing seam metal roof panels on the mansard roofs appeared to be in overall good condition, consistent with their age. Velocity observed areas of mold/mildew build up along the north and south building roofs near the roof scuppers. Roof inspections and roof cleaning are recommended as part of ongoing maintenance. Depending on the quality of materials and workmanship, standing seam metal mansard roofs can last 30 to 40+ years. Based on the condition of the mansards and the approximate remaining life, the mansards have been excluded from this SIRS. The Association reported that mansard replacement will be included in their traditional reserves.

Photo 4: General condition of standing seam metal mansard roofs

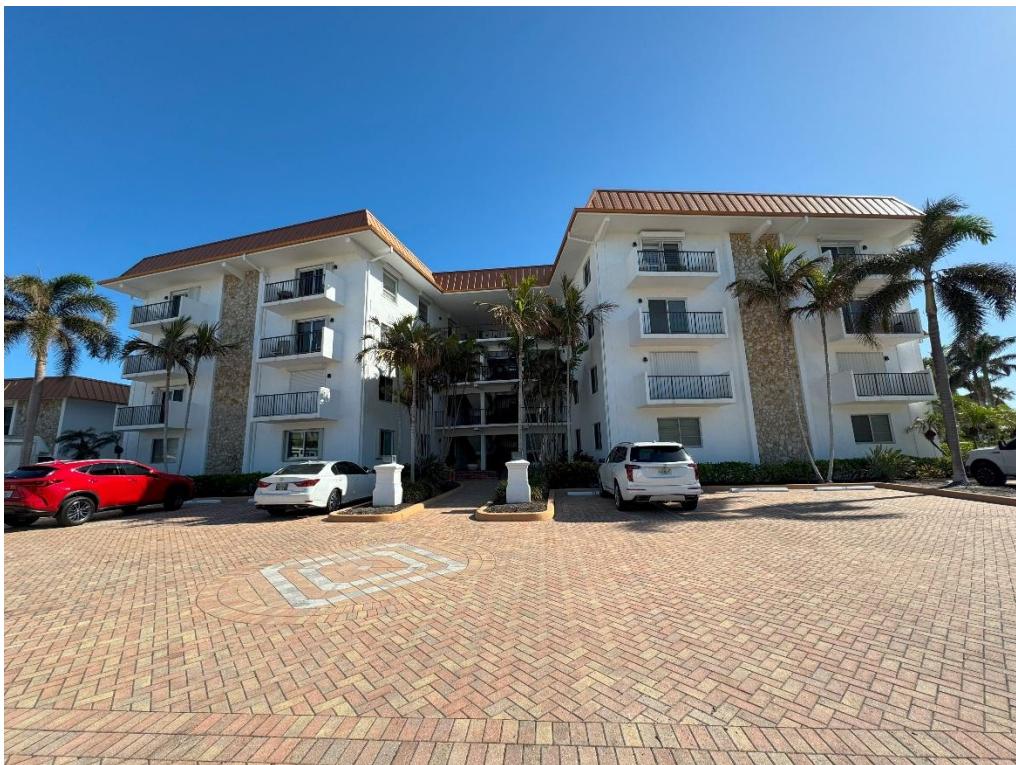
Photo 5: General condition exterior building.

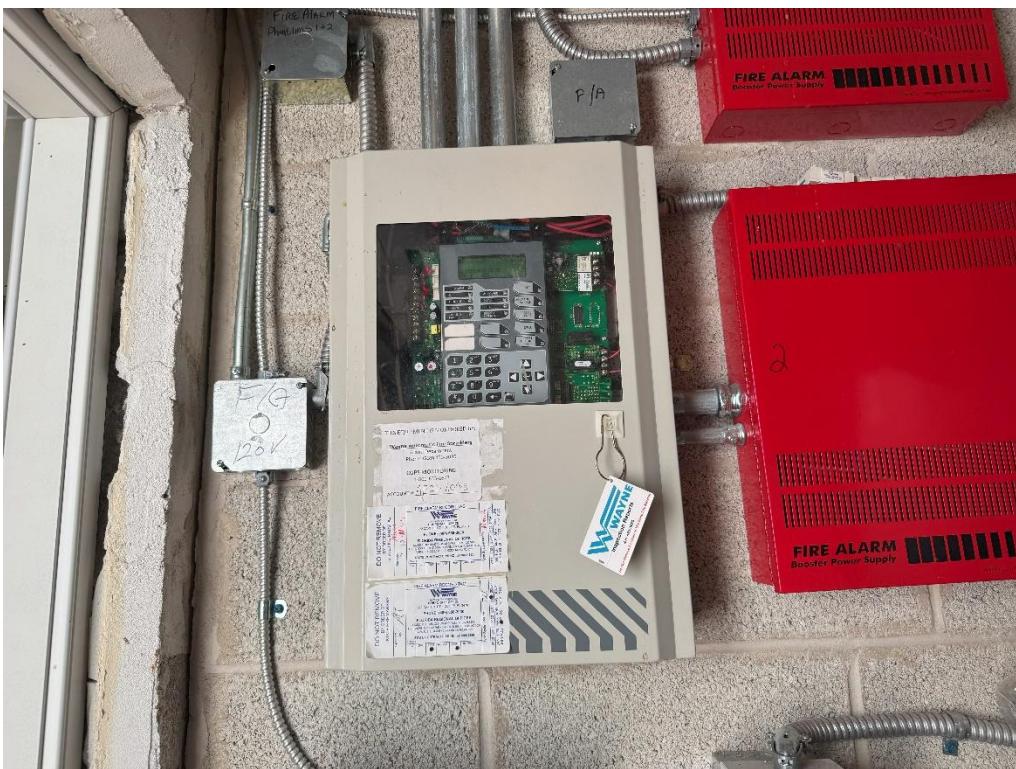
It is understood that Total Fire & Security replaced a communicator in 2025. Total Fire has indicated in a letter dated August 25, 2025 that the fire system is currently functional, operating in compliance with applicable code, and the system does not require upgrades or modernization. Velocity has estimated the replacement and deferred maintenance costs based upon the information provided and experience with similar projects.

Photo 6: General condition of the fire alarm control system

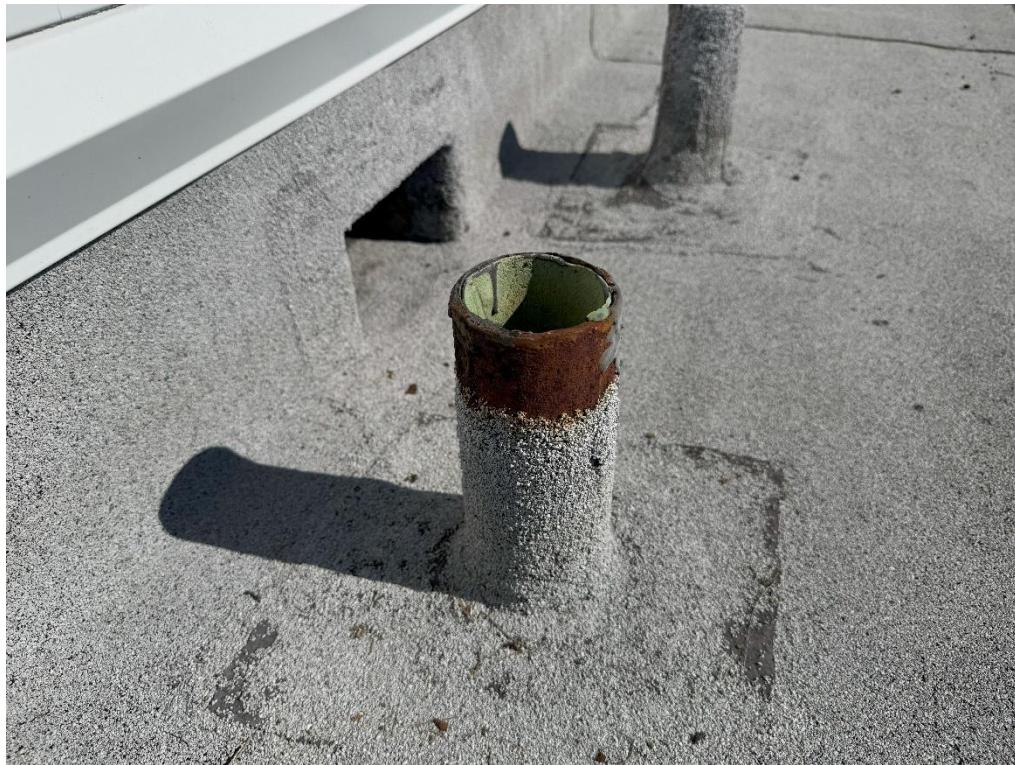
Photo 7: Ventilation Pipe with lining

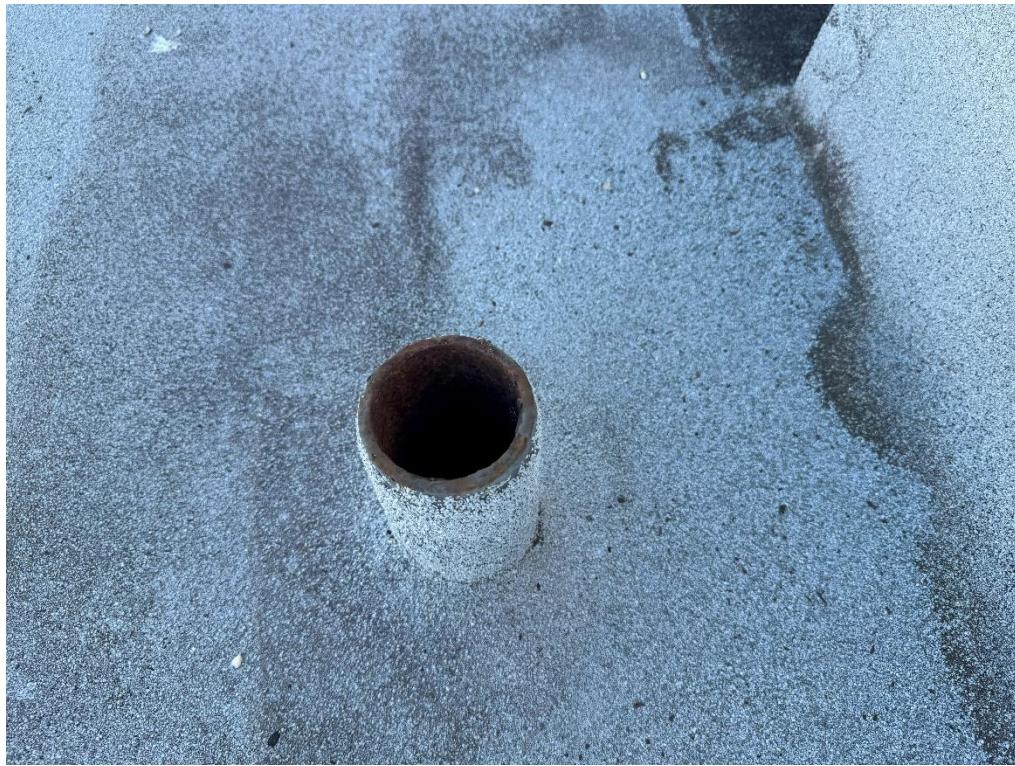
It should be noted that the provided Questionnaire states all cast-iron waste/ventilation pipe stacks have been relined, however, Velocity observed some cast-iron ventilation pipe stacks along the North Building that do not appear to have been relined (see Appendix 3 – Project Photos). Velocity observed above ground sanitary pipes or ventilation stacks that have not been re-lined and it is assumed that this pipe is also in poor condition (based on the age and relining currently underway). Based on this information and the age of the cast-iron pipe (51 years), Velocity recommends that the Association retain a licensed plumber to inspect all remaining or un-lined cast-iron pipe and determine which pipe requires lining or repairs. Additionally, a licensed plumbing or mechanical professional should evaluate the domestic water lines, determine their remaining useful life, and if any major repairs or replacements should be anticipated. Until additional information becomes available, Velocity has included further pipe relining in the SIRS schedule. It is anticipated that the building's CIPP (lined) pipes have a remaining useful life that exceeds 25 years. Therefore, upon completion of repairs and relining all corroded or deteriorated cast-iron pipe, consideration can be given to removing the Cast Iron Pipe Relining line item in a future SIRS update.

Photo 8: Ventilation Pipe without lining

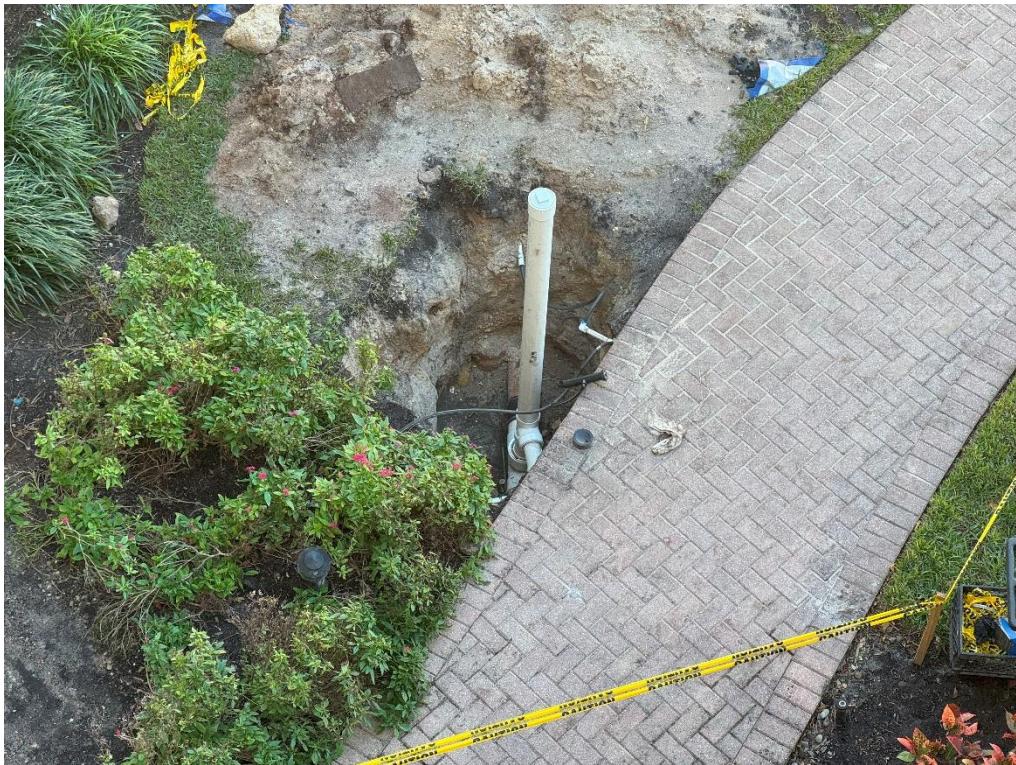
The Association provided Velocity with an authorized proposal, dated 08/27/2024, from Pipe Restoration Solutions, Inc. (PRS) to perform required repairs and replacement of deteriorated cast-iron pipe. The scope of the proposed work generally consisted of installing a Cured-In-Place Pipe (CIPP) lining along the underground main drain and underground lateral runs, correcting a misaligned pipe at Unit 103, and replacing any necessary pipe under the pool pavilion located at the center of the property. PRS performed the required repairs for a total cost of \$199,905.

Photo 9: Ongoing repairs of underground plumbing systems

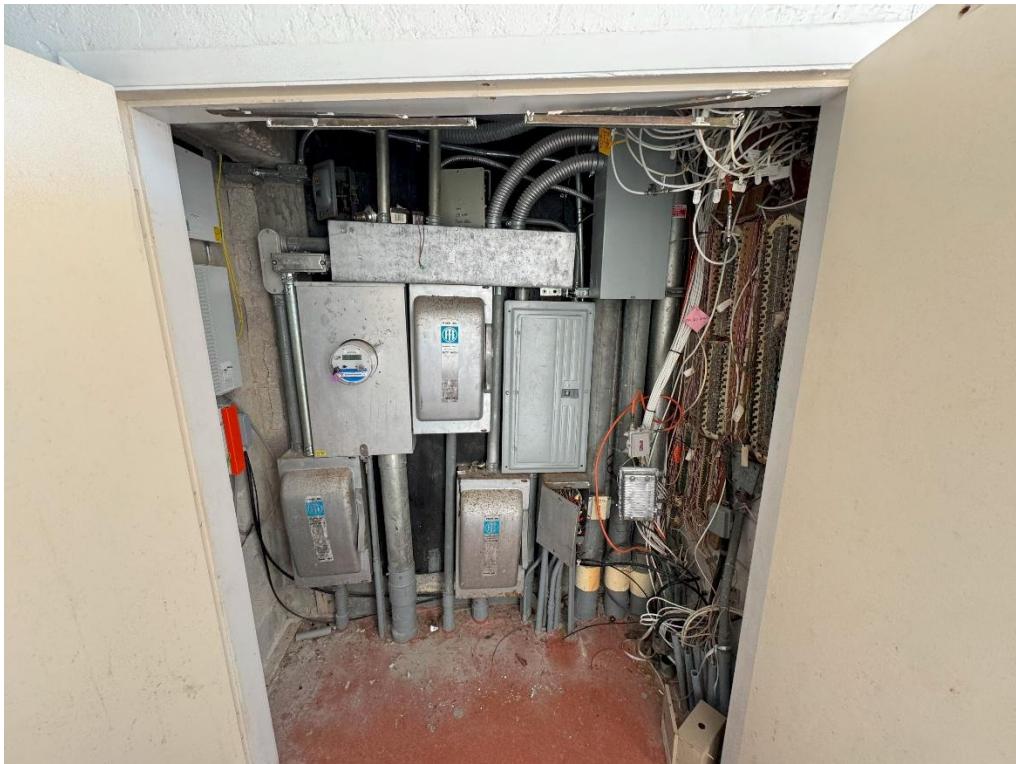
Photo 10: General condition of electrical equipment

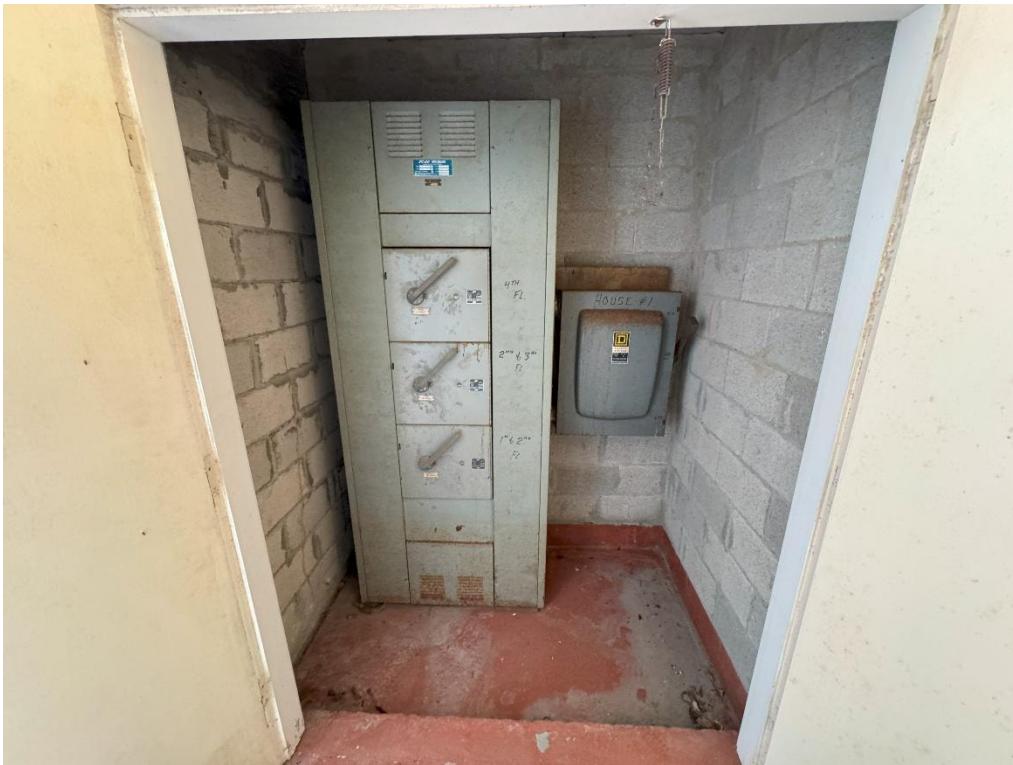
Photo 11: General condition of electrical equipment

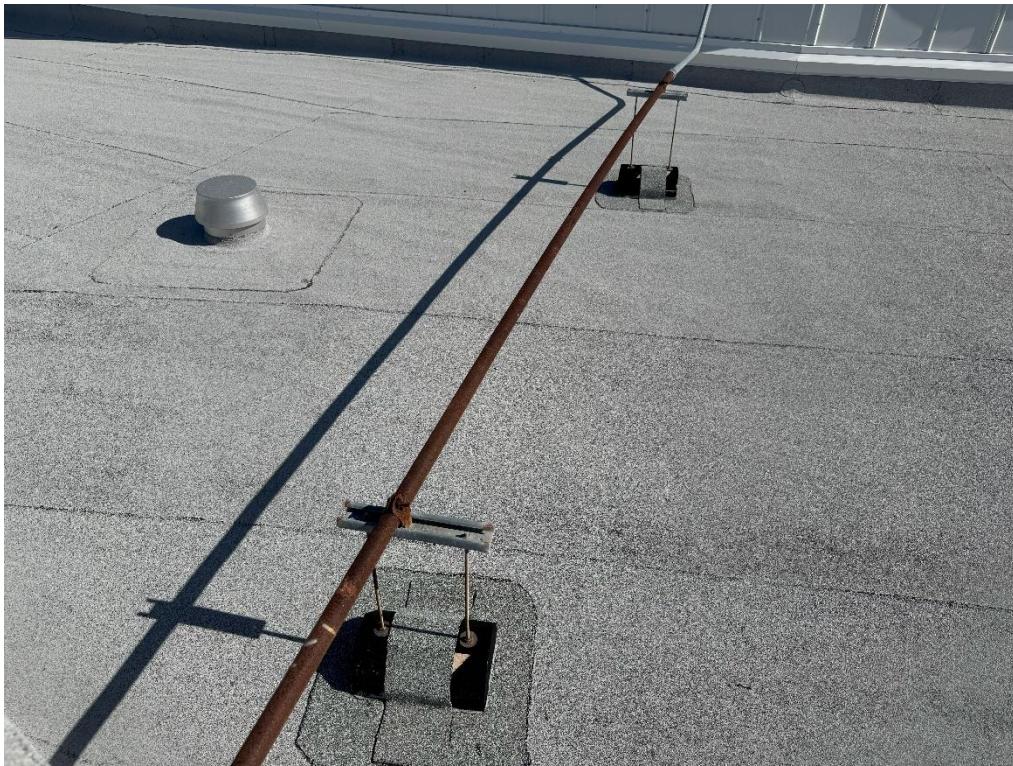
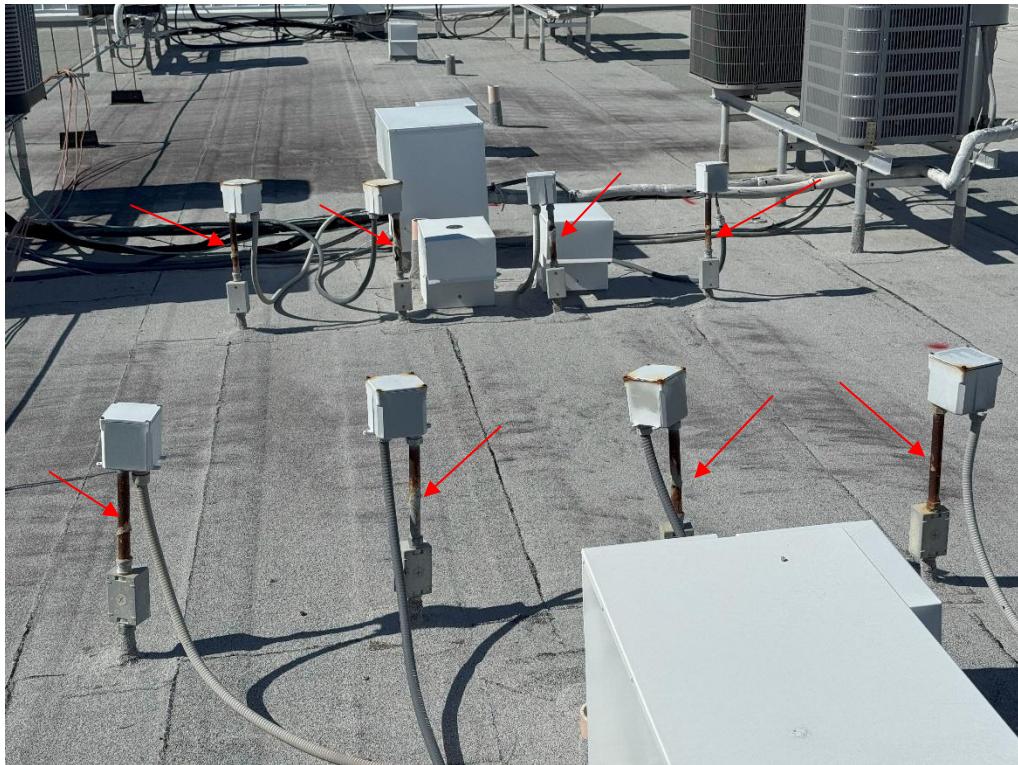
Additionally, Velocity observed rusted electrical conduit and junction boxes for the HVAC equipment on the roof. The rusting conduit and junction boxes should be replaced.

Photo 12: Rusted electrical conduit on the roof

Photo 13: Rusted electrical conduit on the roof

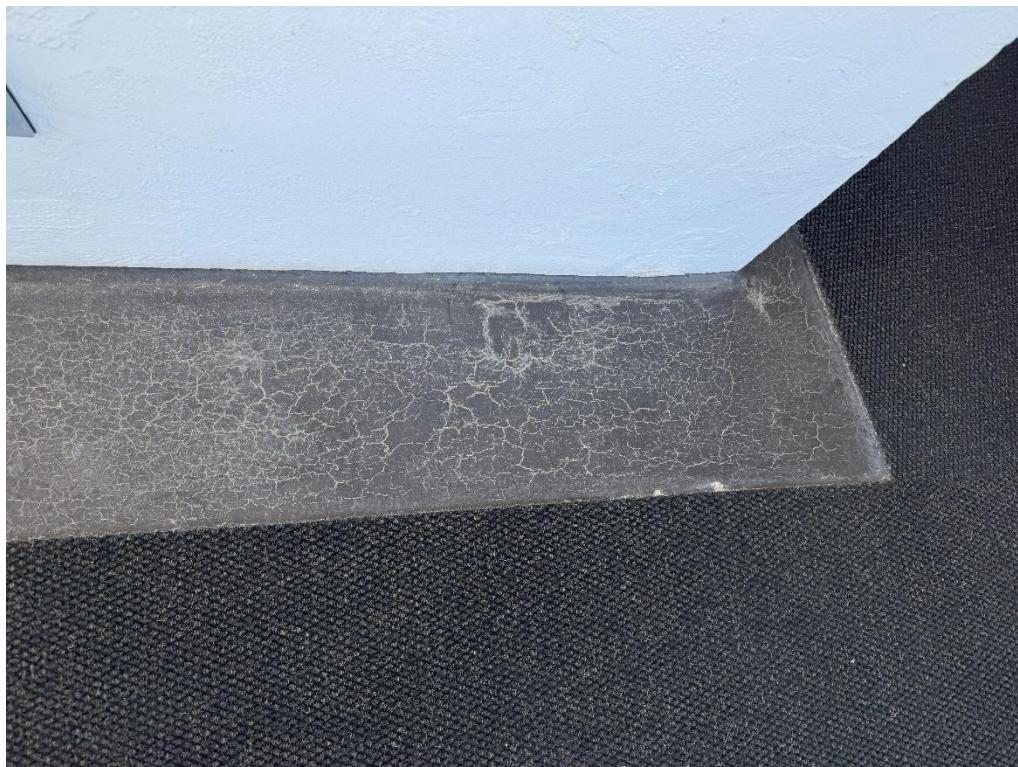
There is carpet installed on the common area walkways and stairs. Below the carpet, it appears that walkways and stairs have been painted or coated with an acrylic or similarly based product. The paint or coating is cracked and failing in many areas. Carpet acts like a sponge, contributes significantly to water intrusion, and should not be installed on exterior concrete slabs. Acrylic or paint products on slabs may offer some protection from water intrusion; however, they are not comparable to a waterproof coating system. Without a waterproof coating or protection from water intrusion, spalling can occur due to excess moisture in the concrete and subsequent corrosion of the embedded steel reinforcement. Velocity recommends that the Association perform a waterproofing project for the elevated walkways and stairs. This project is likely to include removal of all floor finishes (carpeting and coatings), and application of a high-performance waterproofing system. Based on the poor condition of the walkway aluminum handrails, the Association should consider replacing them at the same time. The useful life and cost of waterproofing can vary significantly (approximately 5 to 20 years), depending on the product that is applied, and maintenance performed over the life of the system. The estimated cost to waterproof the walkways is approximately \$212,000 (\$20.00 per square foot). It is understood that the Association is planning on performing this project in conjunction with a walkway handrail replacement project in 2026. Velocity has estimated the waterproofing project costs based upon the estimated square footage and experience with similar projects. It is recommended that the Association retain Velocity to prepare waterproofing and railing replacement specifications and bid this project out to qualified contractors to obtain actual costs for this project.

Photo 14: Typical failing coating along elevated walkway slabs

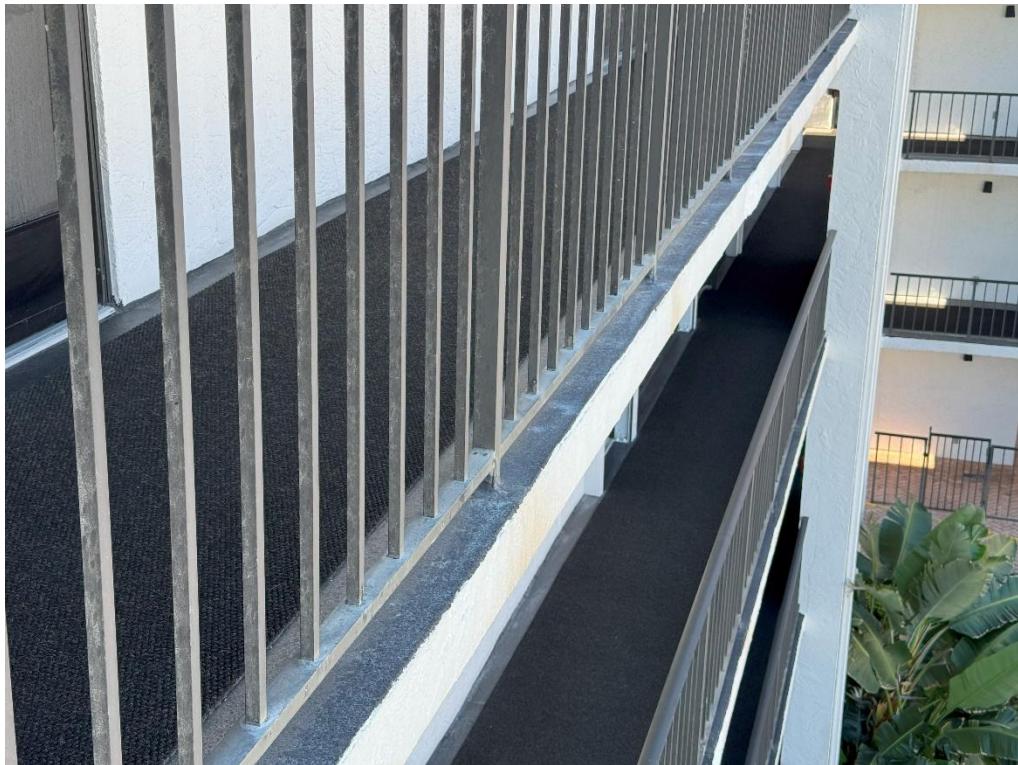
Photo 15: Rust stains along elevated walkway slab edges

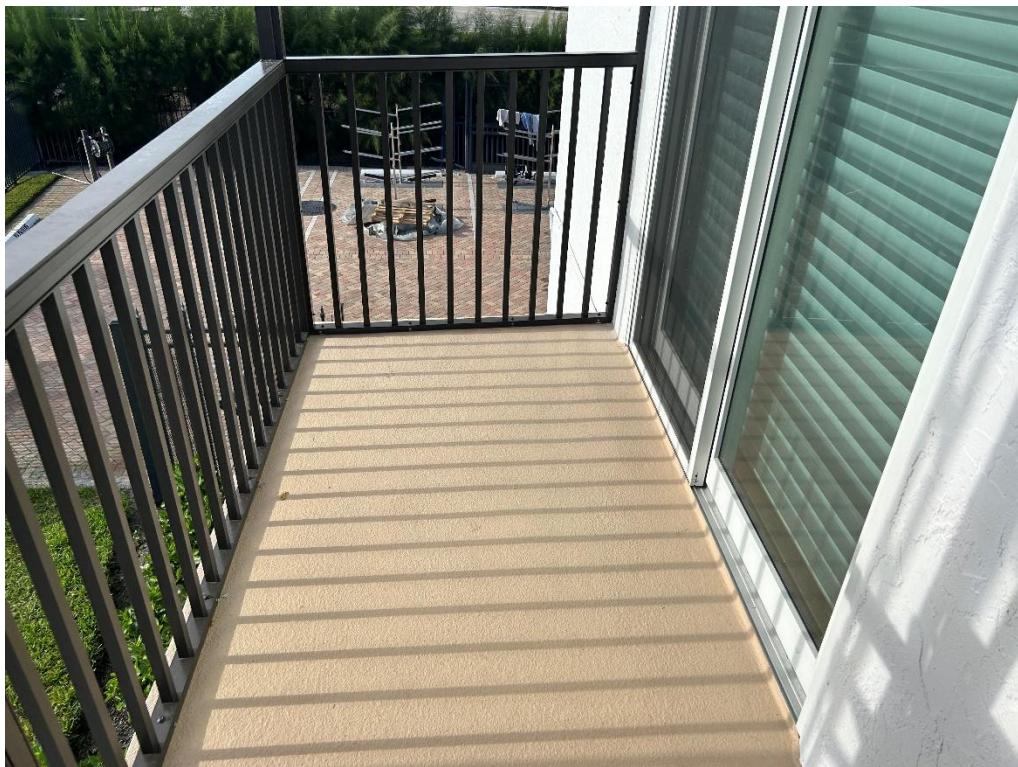
installed waterproofing membranes and based on Velocity's limited observations, they appear to be in good condition. As noted in Section 1.1, RL James installed a new Sikalastic waterproofing system along the east elevation unit balconies of the north, south and west buildings and the north balcony of Unit 416 as a part of the 2024 concrete repair project. This waterproofing is new and in excellent condition.

Photo 16: New Waterproofing installed on balconies.

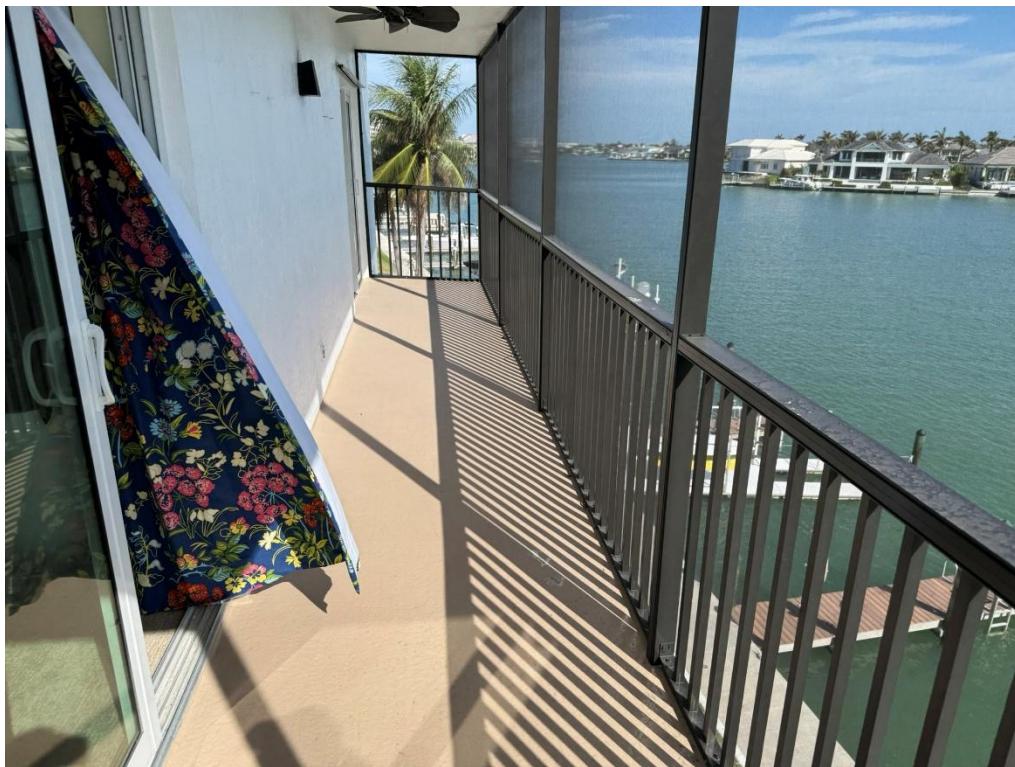
The aluminum screen enclosures on all balconies were replaced as part of the 2024 repair project. These aluminum enclosures are expected to have a useful life that exceeds 25 years. Therefore, replacement of aluminum screen enclosures has been excluded from this SIRS. As noted in Section 2.6, the aluminum handrails are assumed to be original (51 years old), are in poor condition, and replacement is recommended. Therefore, an Aluminum Handrail Replacement Line Item has been included in the SIRS schedule. It is recommended that this is performed in conjunction with the walkway waterproofing project. Replacement costs for the aluminum handrails have been estimated based on a proposal that was provided by the Association for replacement of railings at a nearby, nearly identical property, a standard aluminum finish, and Velocity's experience with similar projects.

Photo 17: Typical New Aluminum enclosure

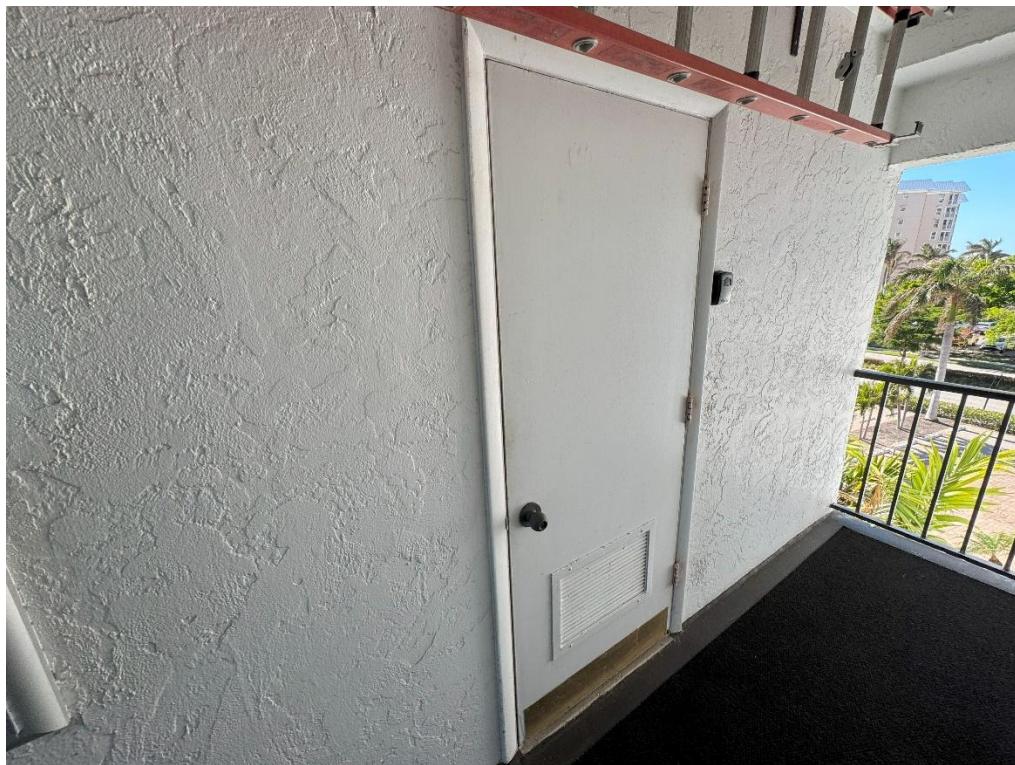
Photo 18: Typical Condition of unit storage doors

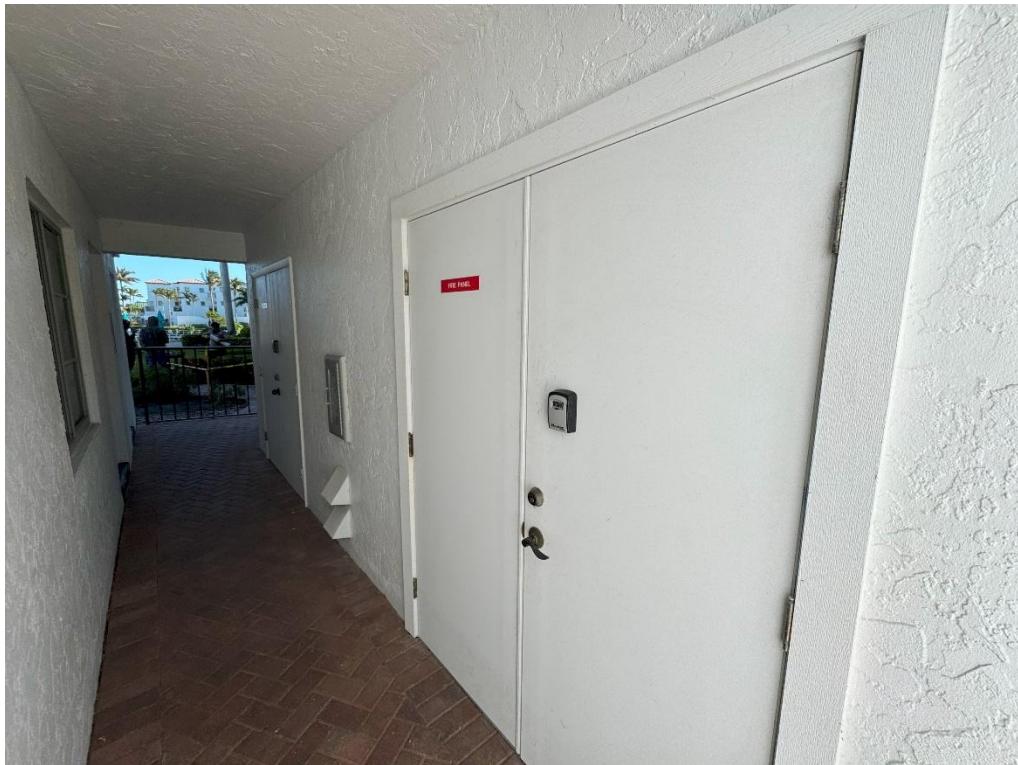
Photo 19: Typical condition of service equipment doors
