Phase 1 Milestone Inspection Report

Velocity Project Number: 23-480

Date: December 19, 2024

Bordeaux Club Condominium

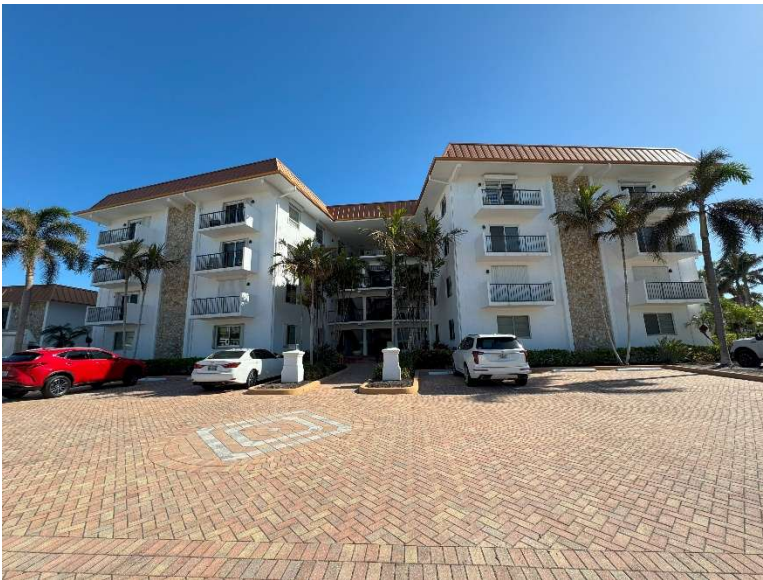
PHOTOGRAPH #1
Bordeaux Club
Building Exterior

General view of West building – West
Elevation

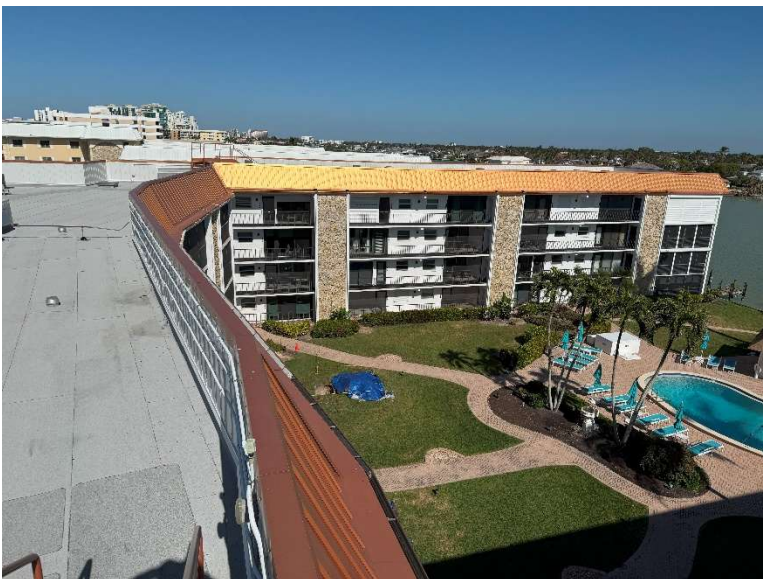
PHOTOGRAPH #2
Bordeaux Club
Building Exterior

General view of North building – South
Elevation

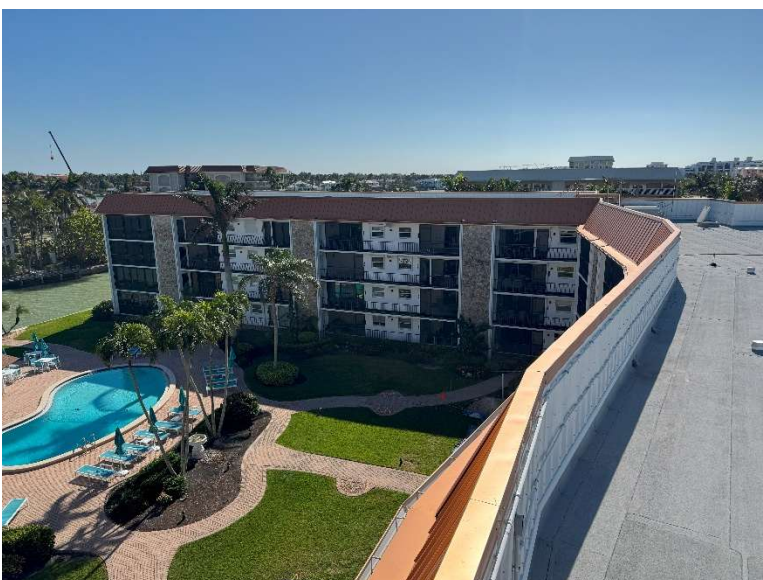
PHOTOGRAPH #3
Bordeaux Club
Roof

General view of south building – North
Elevation

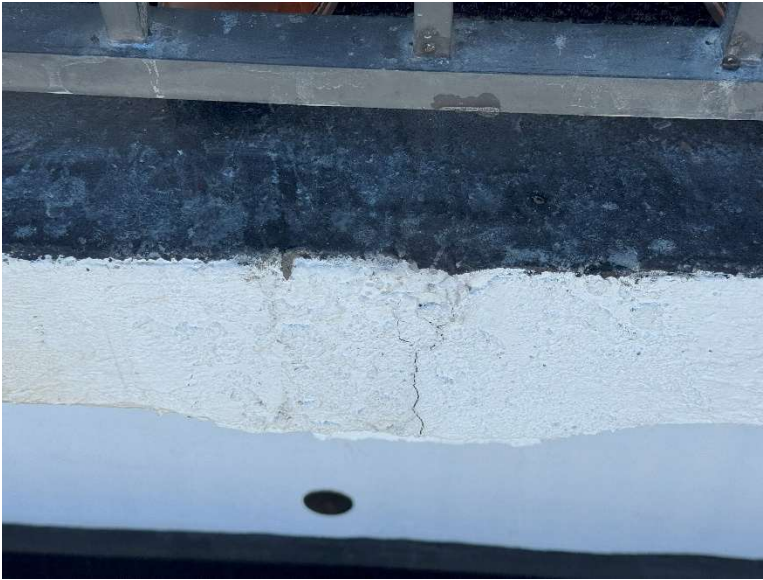
PHOTOGRAPH #4
Bordeaux Club
Elevated Walkway Slab

- ✓ Typical minor cracking in the elevated walkway slab edges of the north, south, and west buildings at or adjacent to the expansion joints.

Typical cracking along the elevated walkway slab edge. Crack shown is located between units 313 and 314. The cracking was noted adjacent to the walkway expansion joint.

The minor cracking along the slab edges of elevated walkways is typical at expansion joints and is likely due to movement or expansion and contraction between the two adjacent slabs. RL James repaired obvious concrete spalling in some of these areas and Velocity investigated instances of this cracking as part of the concrete restoration project. The minor cracking is likely limited to the stucco on the slab edge or the concrete topping. Velocity recommends that this minor cracking be addressed/repared and expansion joints replaced as part of a walkway waterproofing project.

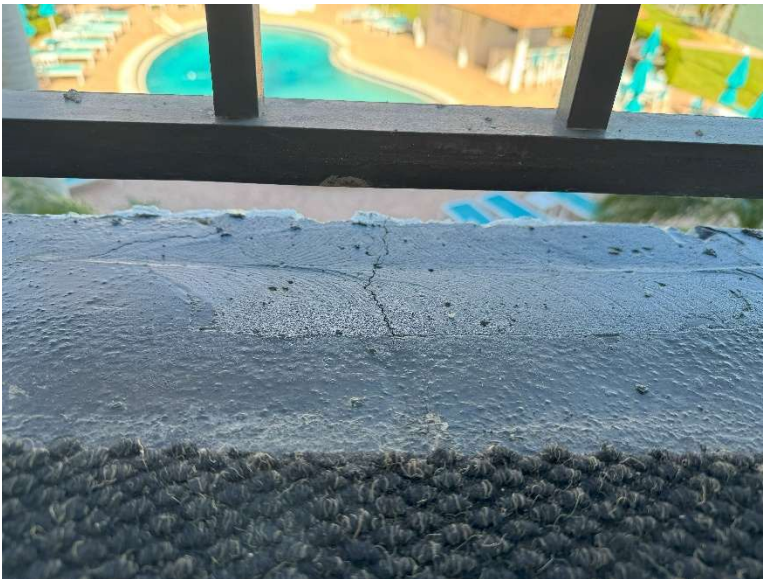
PHOTOGRAPH #5
Bordeaux Club
Elevated Walkway Slab

Cracking along the elevated walkway slab edge. Crack shown is located between units 314 and 315. The cracking was noted adjacent to the walkway expansion joint.

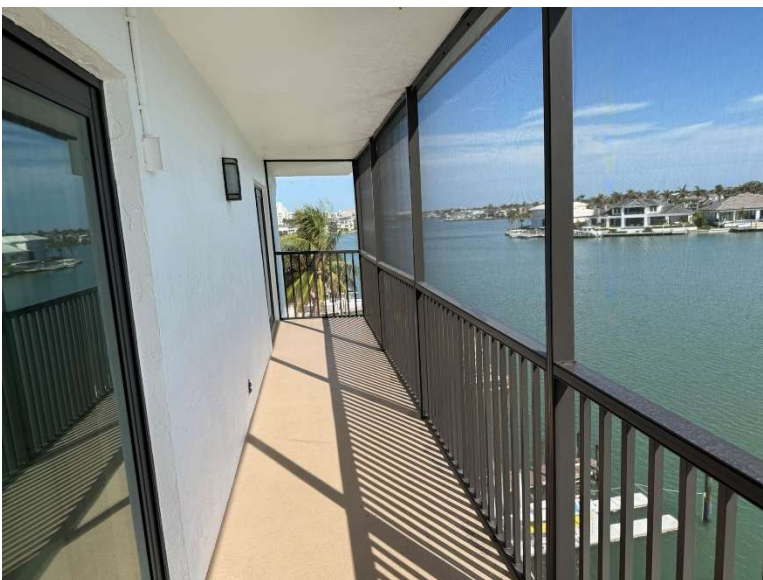
PHOTOGRAPH #6
Bordeaux Club
Elevated Unit balcony slab

Typical condition of unit balcony slabs, post-concrete restoration.

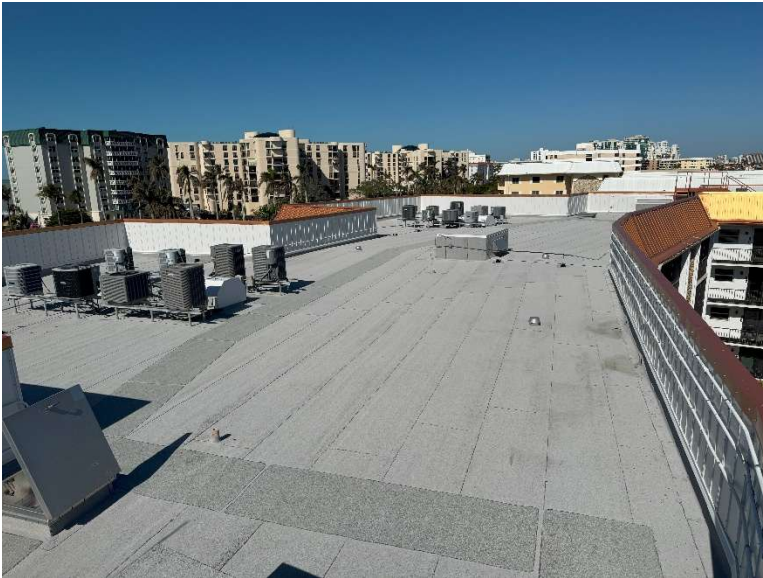
PHOTOGRAPH #7
Bordeaux Club
Roof

General condition of the roofing system along the building.

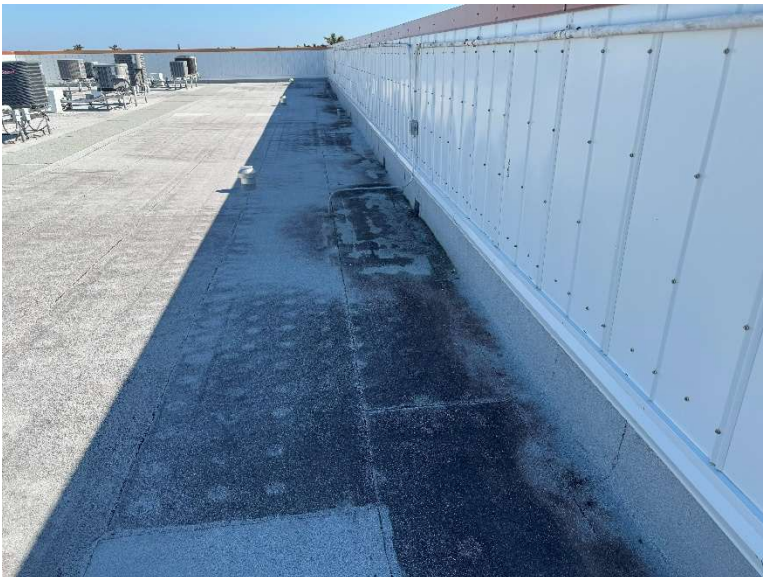
PHOTOGRAPH #8
Bordeaux Club
Roof

The roofs were in overall good condition and no damage or deterioration was observed. However, there are areas of failing or missing roof cement / sealant along the scupper drains and signs of standing water adjacent to the roof scuppers.

Signs of standing water adjacent roof scuppers.

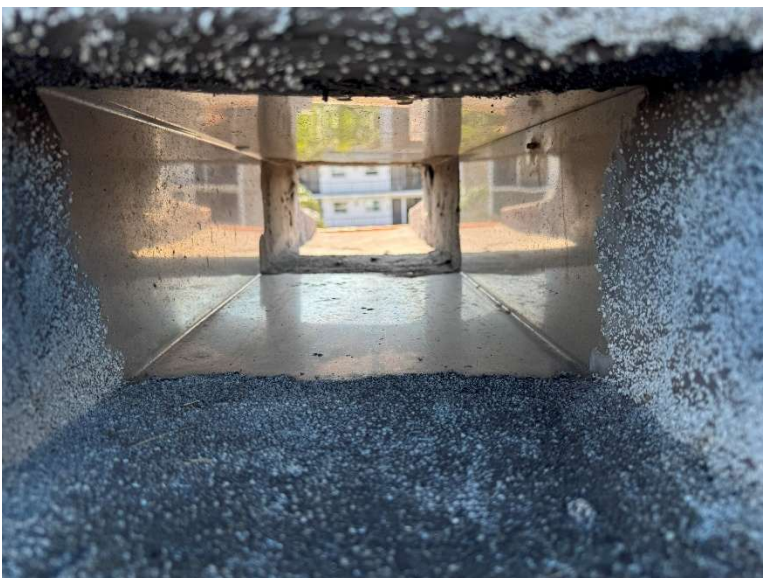
PHOTOGRAPH #9
Bordeaux Club
Roof

Typical condition of roof scuppers.

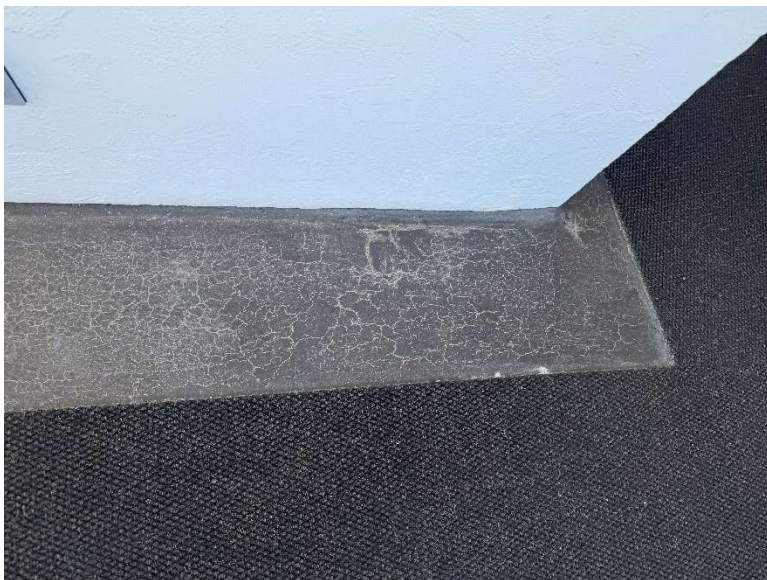
PHOTOGRAPH #10
Bordeaux Club
General Observations

Typical failing coating along elevated walkways.

Regarding waterproofing and expansion joints, a failed coating or joint can allow water intrusion to occur and is likely to cause further concrete spalling. Therefore, Velocity recommends that the Association begin planning to perform a walkway waterproofing project in the near future. This should include stripping carpet and existing paint from the walkway slabs, replacing all expansion joints, and coating with a high-performance waterproofing system.

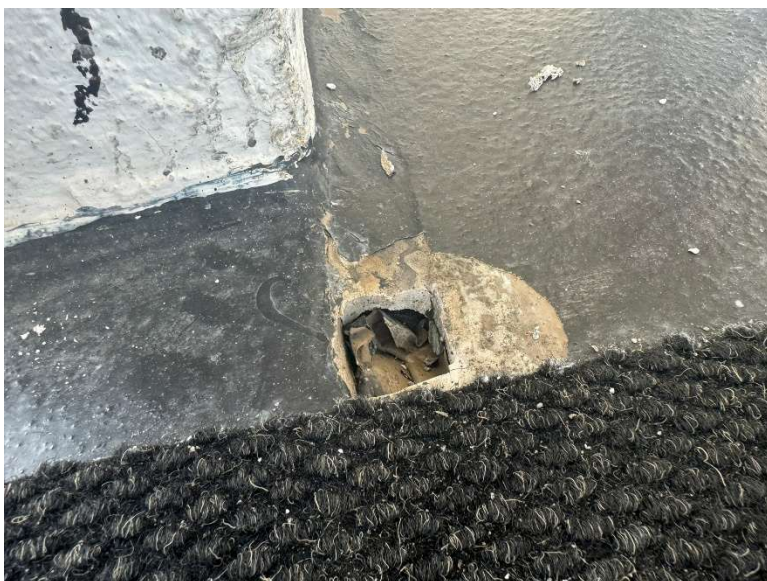
PHOTOGRAPH #11
Bordeaux Club
General Observations

Typical failed elevated walkway expansion joint. It should be noted that this joint was replaced as part of the repair project.

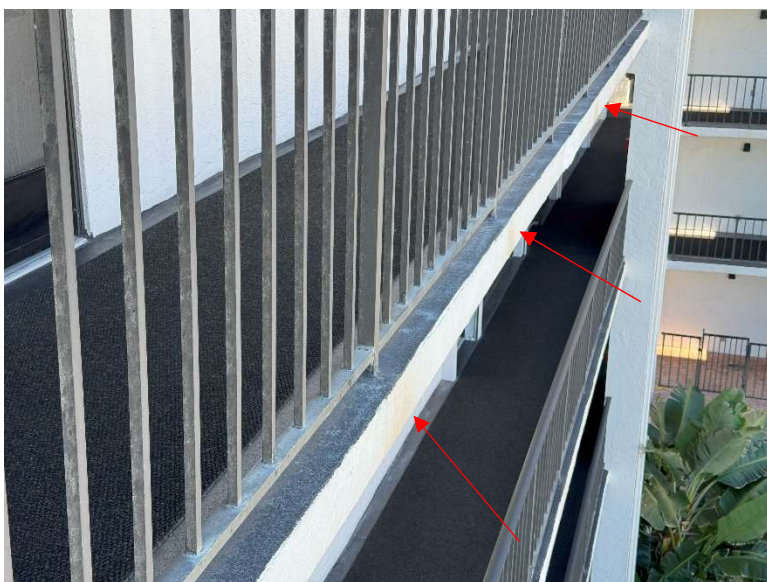
PHOTOGRAPH #10
Bordeaux Club
General Observations

Additionally, the rust staining along the walkway slabs at aluminum handrail post pocket locations is likely an indication that the railing posts are corroding within the slab. Based on the poor condition of the handrails and

Typical condition of walkway guard rails and rust staining along elevated walkway slab edges.

the corrosion that is likely occurring, Velocity recommends that all handrails be replaced. It is recommended (and cost-effective) to replace the handrails as part of the walkway waterproofing project.
