Inspection Report

The Bordeaux Club
Bordeaux Club-2900 Gulf Shore Blvd N
2900 Gulf Shore Blvd N
Naples, FL 34103

Site Overview

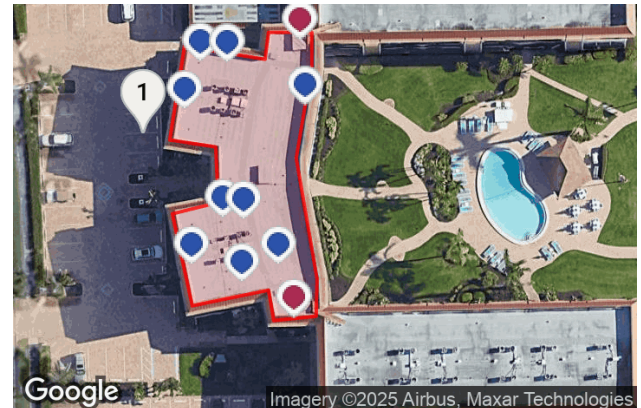
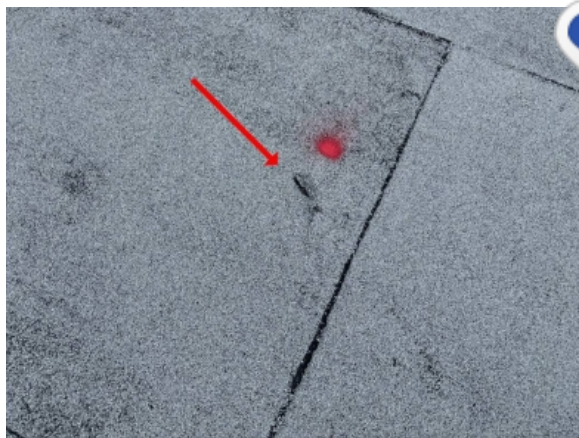
Membrane - Punctures/Rips/Tears (Emergency)

Quantity: 24 EA

These deficiencies are typically caused by heavy foot traffic by other trades, careless mechanical work, careless installation processes or storm related weather events.

Clean and prep the area around the puncture, rip or tear and repair according to the existing type of roof system meeting the minimum industry standards for the type of repair needed.

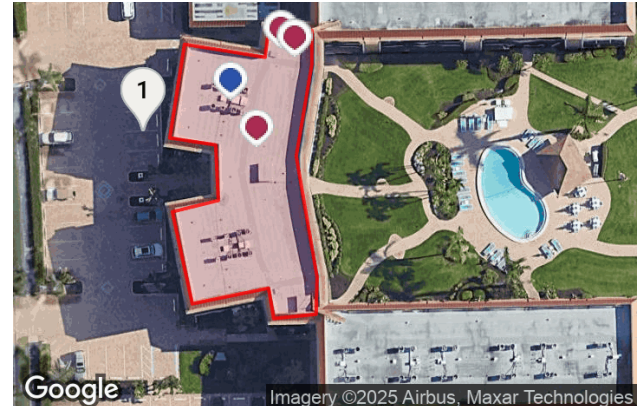
Fasteners - Failing/Missing (Emergency)

Quantity: 8 EA

As the building moves and flexes the fasteners will loosen up and eventually back out completely resulting in water infiltration.

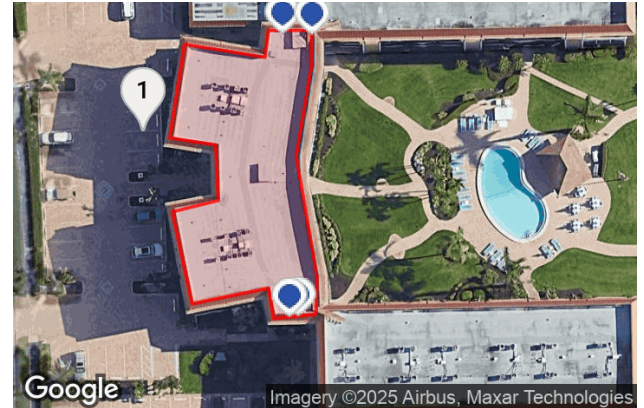
Caulking (Emergency)

Quantity: 16 LF

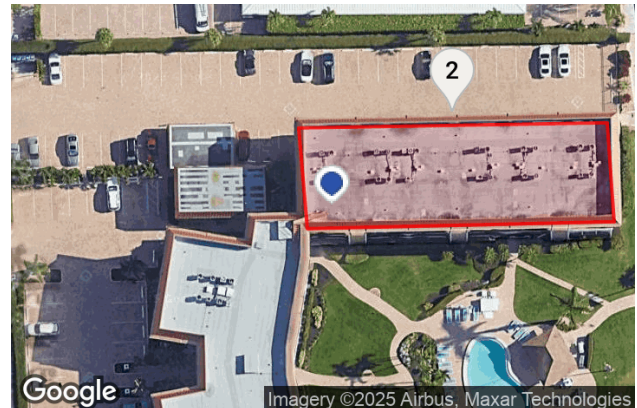
Penetrations - Pitch pan sealant failure (Emergency)

Quantity: 1 EA

Over time, pitch pan fillers fail from age fatigue, cracking, shrinking, or separating from the pipes or conduits in the PP allowing water to enter the building.

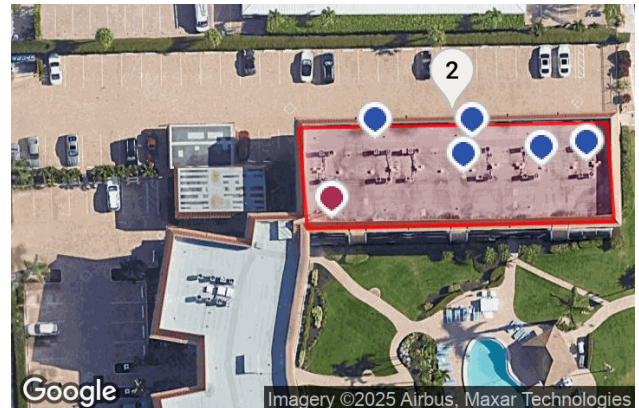
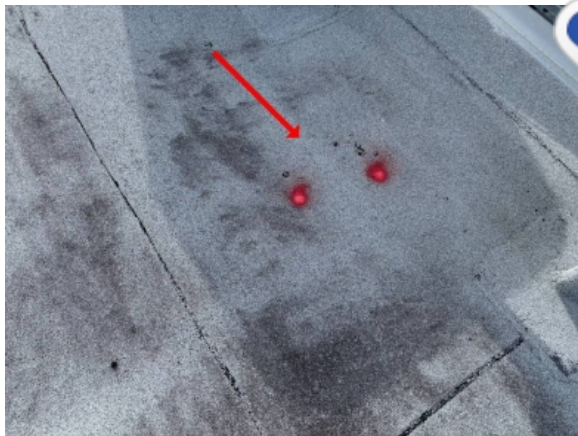
Membrane - Punctures/Rips/Tears (Emergency)

Quantity: 13 EA

These deficiencies are typically caused by heavy foot traffic by other trades, careless mechanical work, careless installation processes or storm related weather events.

Clean and prep the area around the puncture, rip or tear and repair according to the existing type of roof system meeting the minimum industry standards for the type of repair needed.

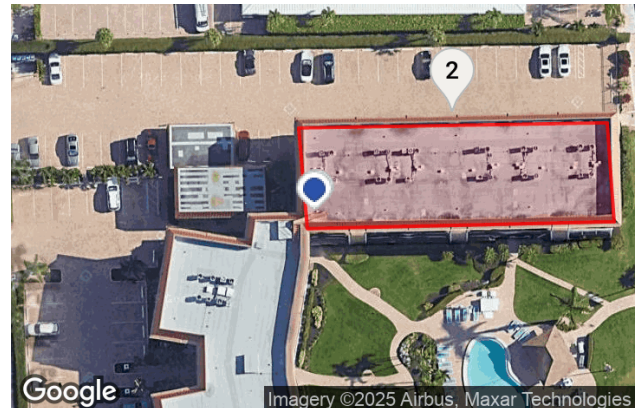
Membrane - Bare Spots

Quantity: 3 EA

Bare spots are areas where the roof's protective surfacing is missing and the underlying asphalt materials are exposed to the sun. Bare spots can be caused by wind, foot traffic, or water. Resurfacing these areas are essential in protecting the existing roof system.

Clean the existing surface free from loose materials. Prime the roof as needed. Install new roof adhesive and surfacing to match existing.

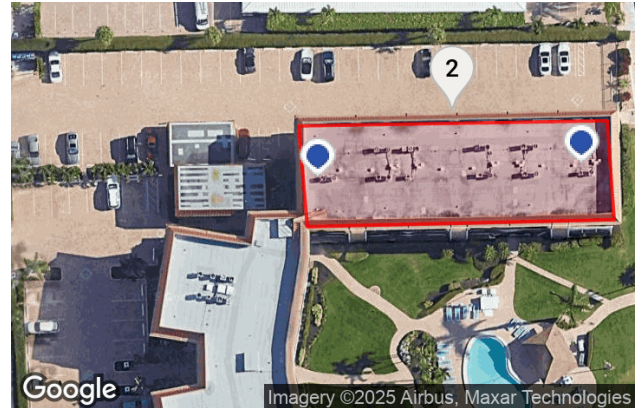
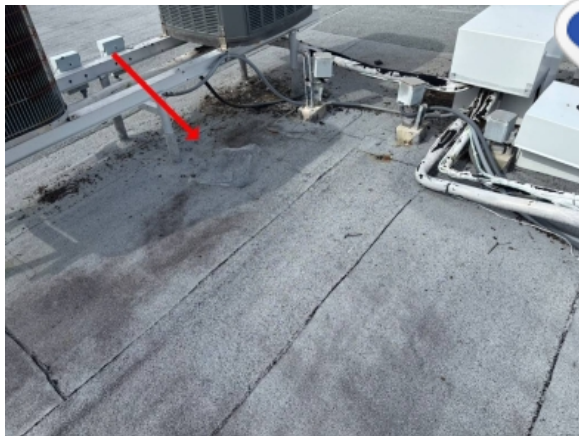
Surface - Debris

Quantity: 1 EA

Loose debris has a high probability of blowing around on the roof and causing damage to the waterproofing membrane.

Remove loose debris from roof area and place in bag, and haul away.

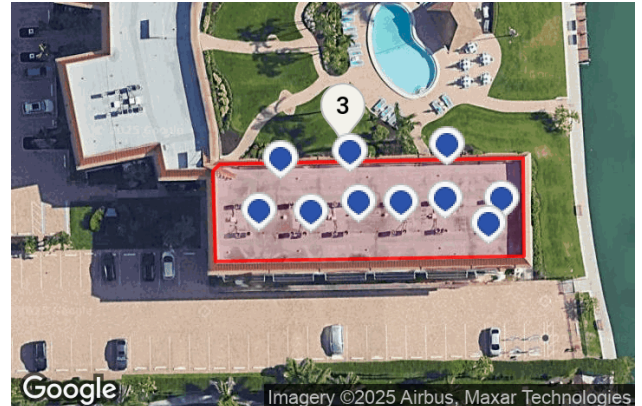
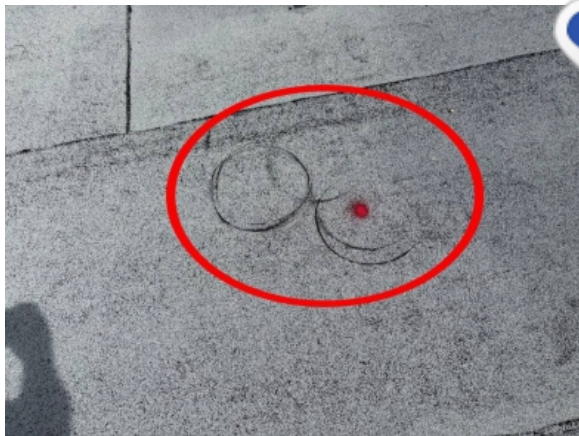
Membrane - Punctures/Rips/Tears (Emergency)

Quantity: 25 EA

These deficiencies are typically caused by heavy foot traffic by other trades, careless mechanical work, careless installation processes or storm related weather events.

Clean and prep the area around the puncture, rip or tear and repair according to the existing type of roof system meeting the minimum industry standards for the type of repair needed.

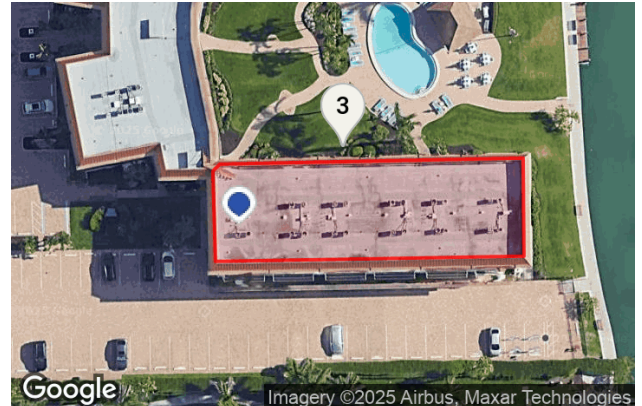
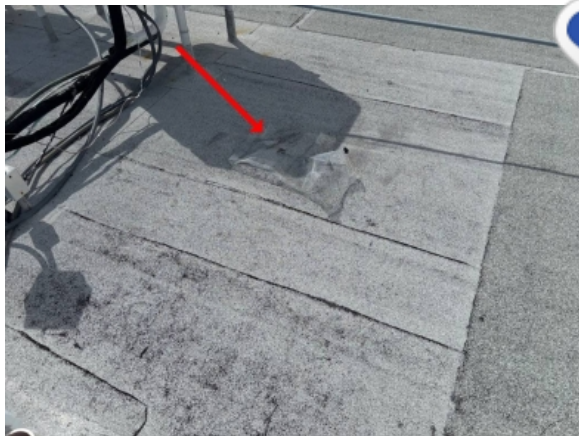
Debris - Trash on Roof

Quantity: 1 EA

Loose debris has a high probability of blowing around on the roof and causing damage to the waterproofing membrane.

Remove loose debris from roof area and include as part of routine preventative maintenance. Inspect and repair damaged membrane resulting from wind blown debris. Price is per bag.

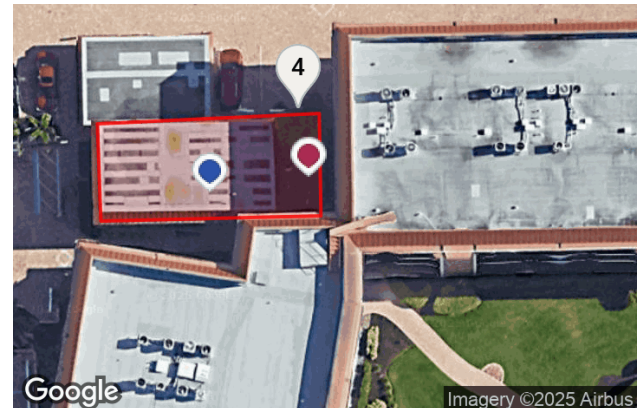
Membrane - Temporary Repair (Emergency)

Quantity: 1 EA

Leak location detected in the roof system allowing water to enter into the building.

Clean the area to the best of our ability and apply water proof sealant to temporarily solve the roof leak.

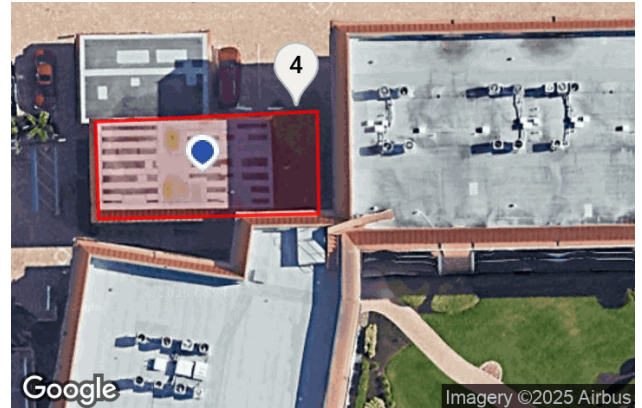
Reroof needed over office

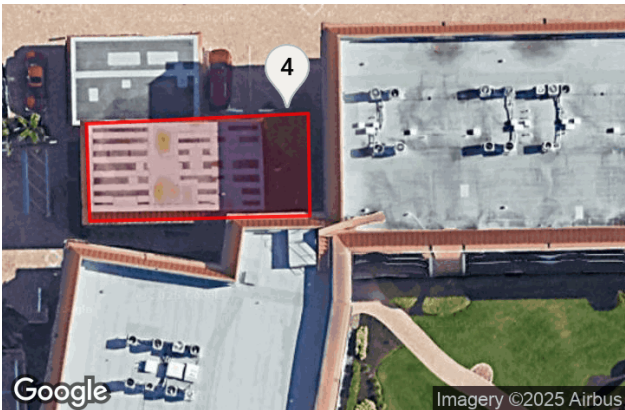
Membrane:	C-
Flashings:	C-
Sheet Metal:	C-
<hr/>	
Overall:	C-

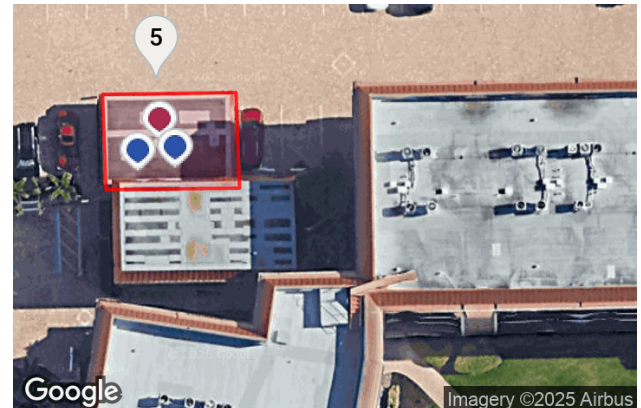
Membrane - Temporary Repair (Emergency)

Quantity: 2 EA

Leak location detected in the roof system allowing water to enter into the building.

Clean the area to the best of our ability and apply water proof sealant to temporarily solve the roof leak.

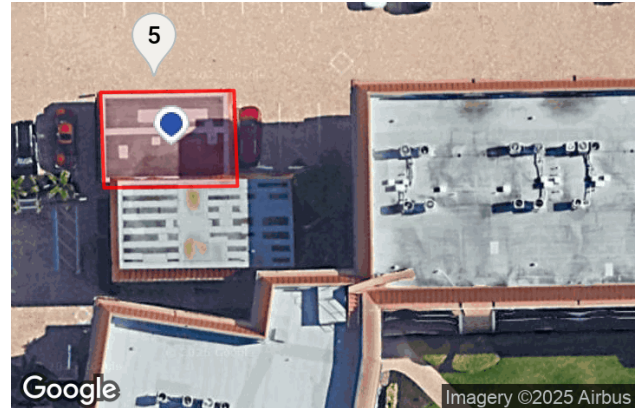
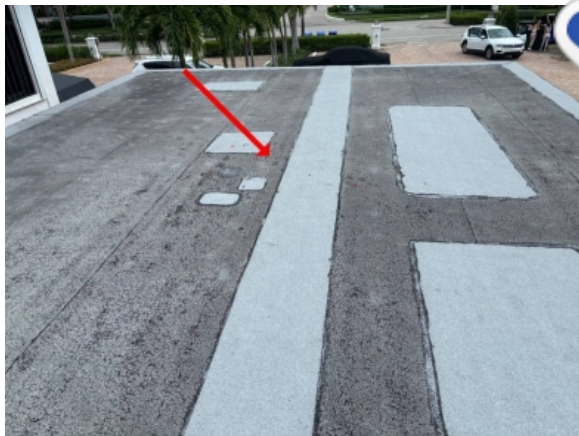
Reroof needed over bike storage

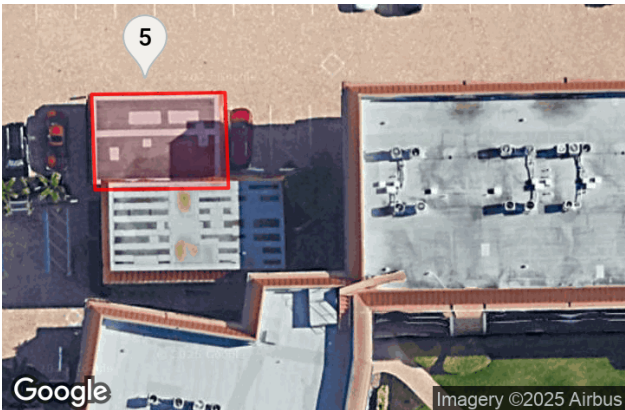
Membrane:	D
Flashings:	D
Sheet Metal:	D
<hr/>	
Overall:	D
Estimated Replace:	2028

Recommendations:
Reroof needed

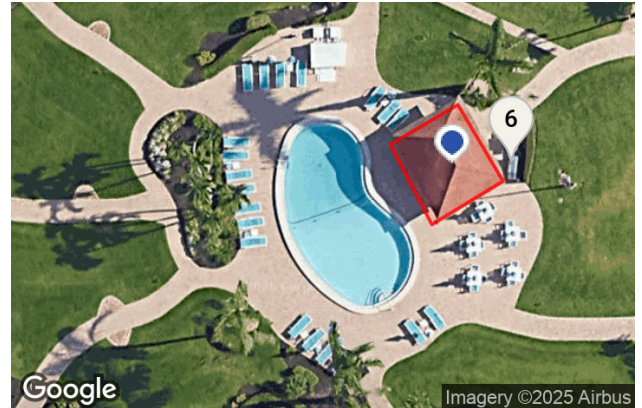
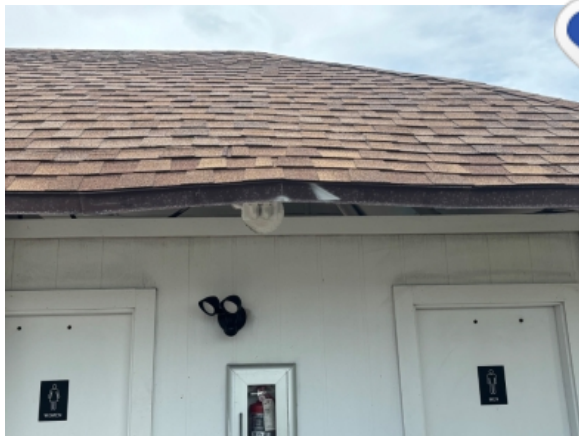
Shingle roof in fair shape

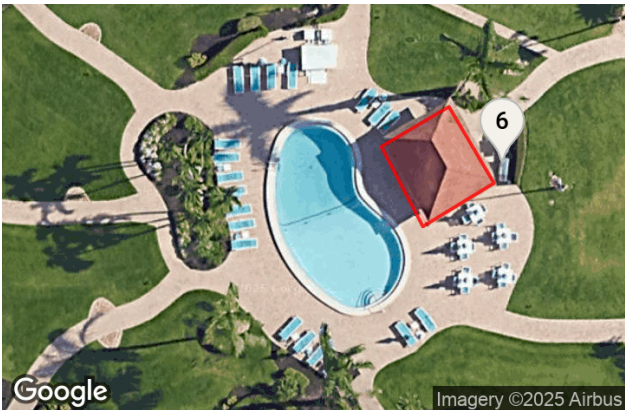
Membrane:	C
Flashings:	C
Sheet Metal:	C
<hr/>	
Overall:	C
